# GFA AD 614

## GFA AIRWORTHINESS DIRECTIVE

- SUBJECT:** Failure of Rudder Lower Mounting Bearing.
- BACKGROUND:** On a DG-100, the Rudder Lower Mounting self aligning bearing moved out of the bearing support and the rudder fell out.

- Subject** : Lower mounting of the rudder
- Effectivity** : DG-100, DG-200, DG-300, DG-400, all models and all ser.no.'s  
DG-500, DG-500M all models up to 5E23  
DG-600, DG-600M all models and all ser.no.'s.

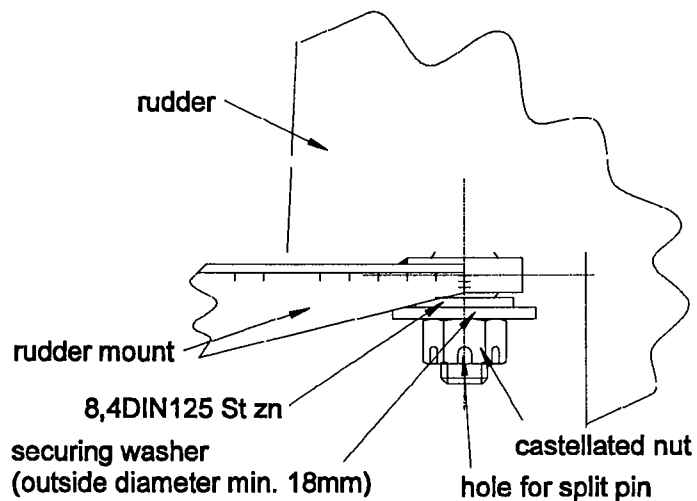
- Reason** : On a DG-100 the universal bearing of the lower rudder mounting slipped out of the bearing support and the rudder fell out.  
As the design is similar on all DG-types this kind of failure may occur on all DG's.  
On later models this connection was secured by an extra securing washer.  
Such a washer must be retrofitted to all DG-types with this TN.

3. Check if a securing washer (min. outside diameter 18mm, 0.71 inch) is installed according to the sketch.
    - a) If yes: The execution of this TN can be entered in the aircraft logs by a licensed inspector without further work to be done.

- b) If no: Remove the castellated nut, install the washer 8.4 DIN9021 and reinstall the nut.
      1. Check if the washer is interfering with the rudder mount. If yes, use a washer 6,4DIN9021 St zn instead, enlarge the 6mm hole to 8mm to enable installation.

2. Check if the split pin can be installed. If yes, secure with a new split pin 2x20 DIN94 zn.If this is not possible, mark the position for a new hole and remove the rudder. Drill a new hole (diameter 2mm, .08 inch) 90° to the existing hole. Reinstall the rudder, use new split pins.
