GFA AD-617
(ISSUE 1)

GFA AIRWORTHINESS DIRECTIVE

TYPE AFFECTED: DUO DISCUS S/N: 1 up to & including 164.

SUBJECT: Possible faulty bonding of Upper spar cap to Spar web.

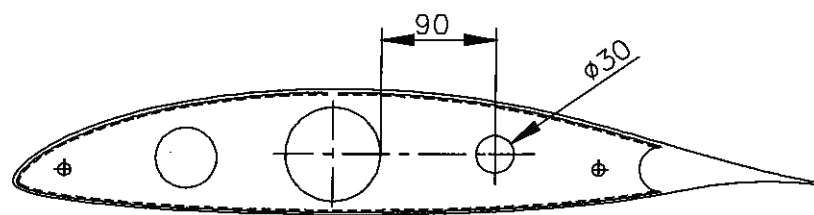
inspection opening in the outer
root rib

- a) Cut the inspection opening in the outer root rib, see page 5.
- b) Remove the inspection opening in the lower surface at the aileron drive (if necessary for the inspection).

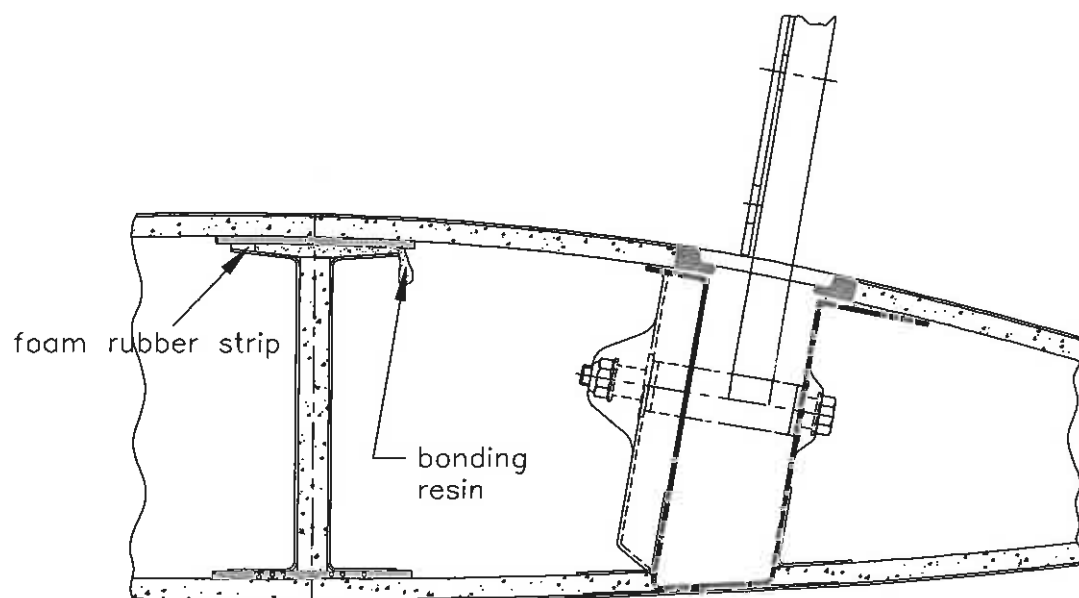
wing section in the
airbrake area

The bonding on the rear side of the spar cap and spar web on the upper wing surface has to be checked, see cross section on page 5.

It is required that the gap between GRFP-spar web and CFRP-spar cap is completely filled with bonding material.

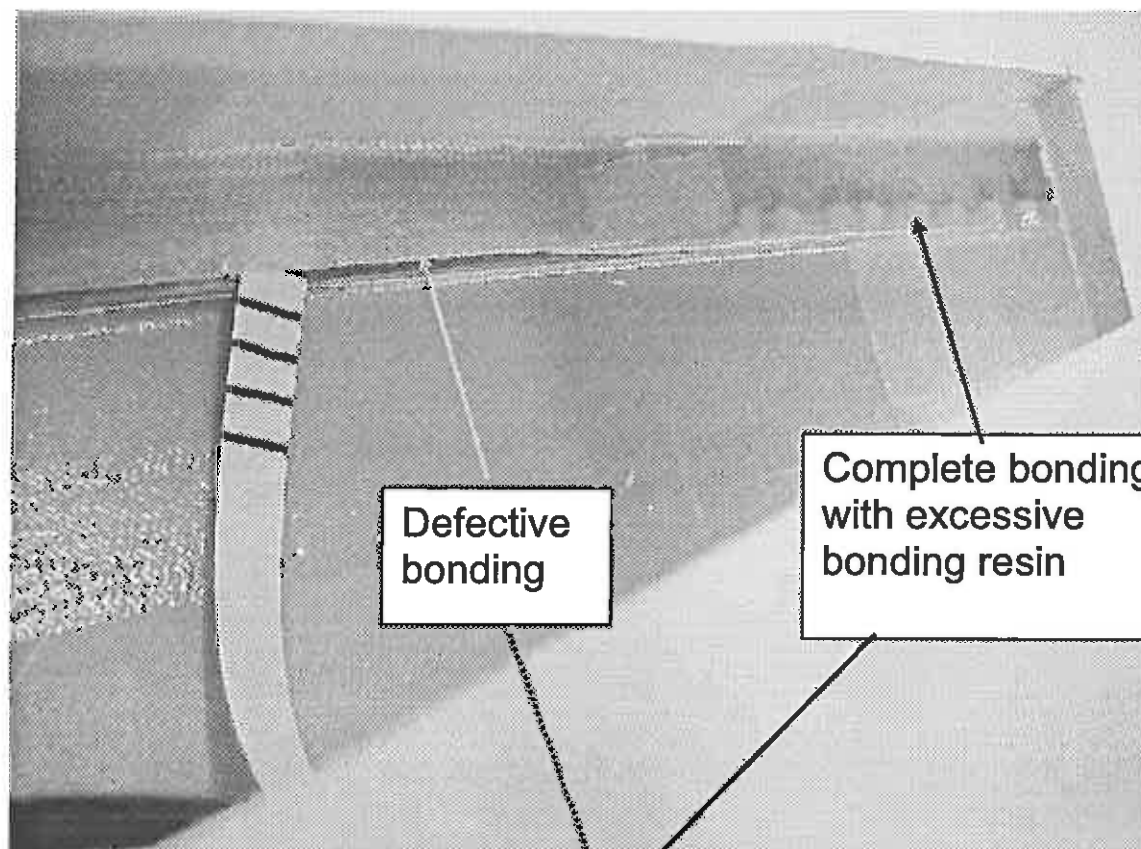
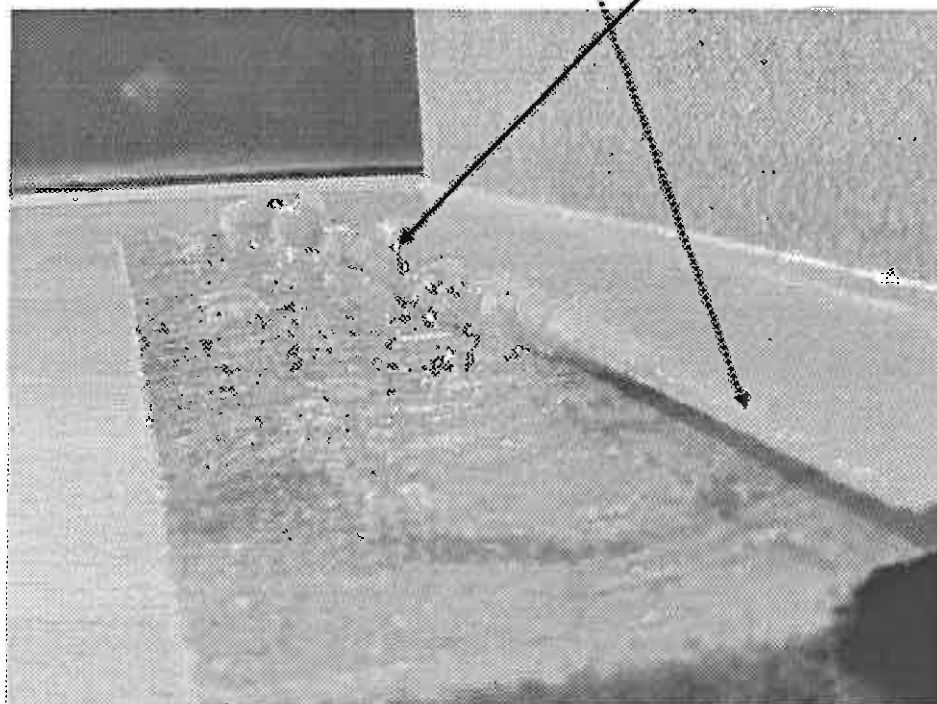
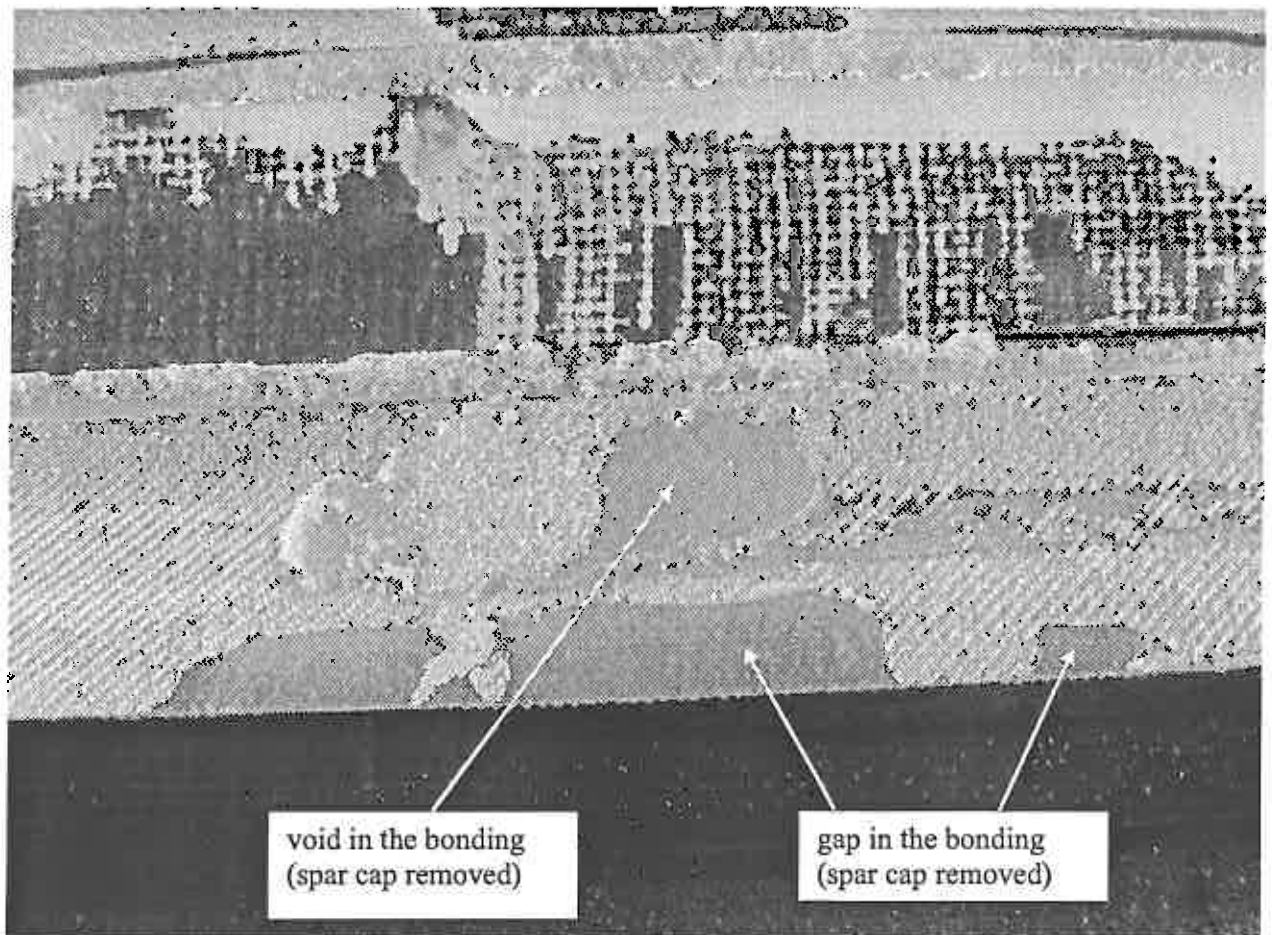
Showcase photos on page 6 and 7 indicate the following:

- a complete bonding with excessive bonding resin
- a defective bonding – insufficient bonding resin

Some photos on page 6 and 7 show examples of defects in the bonding.

Defects have to be repaired according the instructions on page 3 and 4.
