<b>GFA AD-618</b>	<b>ISSUE: 1</b>	<b>16 November 2004</b>	<b>Page 2 of 5</b>
-------------------	-----------------	-------------------------	--------------------

<b>STEMME</b> F & D Design Org.	<b>Service Bulletin</b>		Document Number: <b>A31-10-069</b>
	<b>Connections in the Control System S10</b>		Am.-Index: 01.a
			Page: 4 of 6

## **1 Subject:**

1. *Inspection of the joint between the aileron control rod 10SQ-RMB and the connecting shaft 10SQ-RMW.*
2. *Inspection of all control system joints with circular caulked hinge or ball bearings.*
3. *Safety washer in the aileron system: Inspection of existence / if necessary installation*

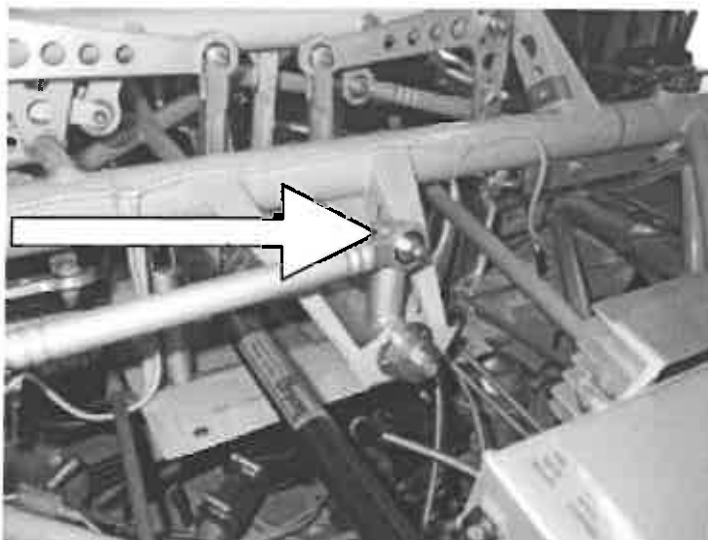
### 5.1 Inspection of the joint between the aileron control rod 10SQ-RMB and the connecting shaft 10SQ-RMW

*The only joint which may completely disengage due to a loose bearing is the connection between the aileron control rod 10SQ-RMB and the connecting shaft 10SQ-RMW.*

The hinge bearing of the joint between the push-rod and the connecting shaft must be inspected for correct position and tight fit. This must be done during each daily inspection and after removal of the upper fuselage fairing.

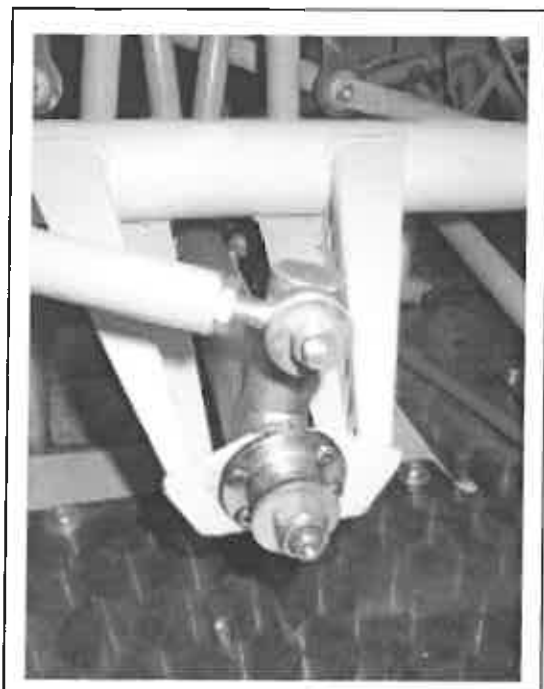
version: steel control system

model S10: 10-03 through 10-56  
model S10-V: 14-001 through 14-003  
14-003M through 14-056M

The connection between the aileron push-rod 10SQ-RMB and the connecting shaft 10SQ-RMW must be secured by a safety washer with a diameter of 20mm (0.79 in.) [DIN 440-06]. This washer prevents a separation of the aileron control system in case of a loose bearing.

This safety washer was not a serial standard for the models S10-V and S10-V and it has still to be installed. For this purpose the joint must be disassembled. The existing bolt must be replaced by the bolt (LN9037-06042) of the modification kit. A washer 10M-282 and another safety washer D440-06 must be installed opposed to the flight direction.

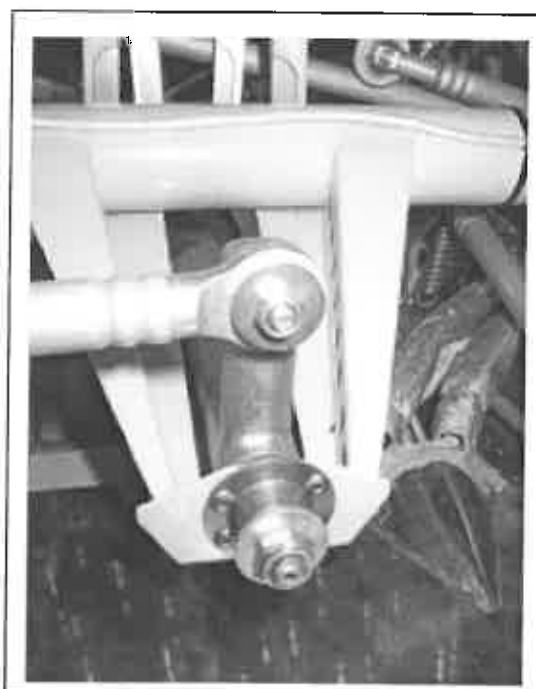
version: aluminium control system

model S10-V: 14-004 through 14-030  
model S10-VT: 11-001 through 11-089
