GFA AIRWORTHINESS DIRECTIVE

TYPE AFFECTED: JANUS, JANUS B, JANUS C, JANUS Ce (TCDS 295)
Ser Nos: 1 to 307.
JANUS CM (TCDS 809) Ser Nos: 1 to 37
JANUS CT (TCDS 809) Ser Nos: 1 to 22
NIMBUS-3D (TCDS 373) Ser Nos: 1, 1/3, 2 to 14.
NIMBUS-3DT (TCDS 847) Ser Nos: 1 to 63.
NIMBUS-3DM (TCDS 847) Ser Nos: 1 to 27.

SUBJECT: Flight Controls:- Elevator control system.

SCHEMPP-HIRTH Flugzeugbau GmbH. Kirchheim/Teck	Technical Note No. 295-30 / 373-9 809-16 / 847-9	Page: 01 No. of pages: 03
<p><u>SUBJECT:</u></p> <p><u>AFFECTED:</u></p> <p><u>URGENCY:</u></p> <p><u>REASON:</u></p>	<p>Elevator control system</p> <ul style="list-style-type: none"> - Sailplane model (ATC No. 295) Janus, Janus B, Janus C, Janus Ce S/N 1 through 307 - Sailplane model (ATC No. 373) Nimbus-3D S/N 1, 1/3, 2 through 14 - Powered sailplane model (ATC No. 809) Janus CM S/N 1 through 37 - Powered sailplane model (ATC No. 847) Nimbus-3DT S/N 1 through 63 Nimbus-3DM S/N 1 through 27 <p><u>Action 1:</u> Prior to further flights!</p> <p><u>Action 2</u> <u>and the following:</u> On the occasion of the next annual inspection, but not later than March 31st, 2005</p> <p>On a Janus Ce with 5872 flight hours a break of the attachm

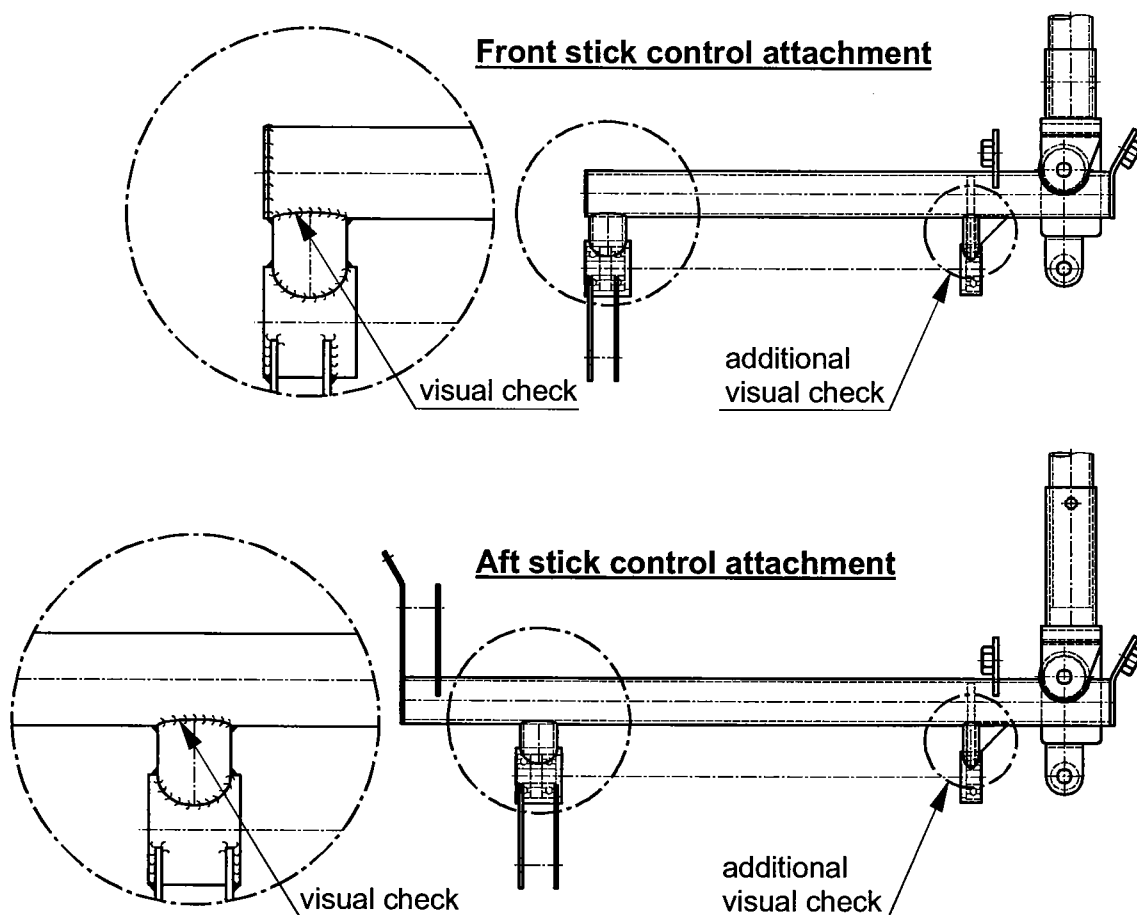
1. The attachments of the stick control in the front and aft seat must be visual checked for cracks resp. damage.

If a damage is detected at the attachments proceed according action 2 and the following.

2. Not reinforced outer attachments of the stick control in the front and aft seat must be reinforced in accordance with the instructions in the appendix.

If the inner attachment is damaged please ask the manufacturer for repair instructions.
