GFA AIRWORTHINESS DIRECTIVE

TYPE AFFECTED: SZD-50-3 PUCHACZ. ALL SERIAL NO'S.

SUBJECT: Failure of Pushrod End Bearing in elevator circuit.

SZD-50-3 PUCHACZ AD-623

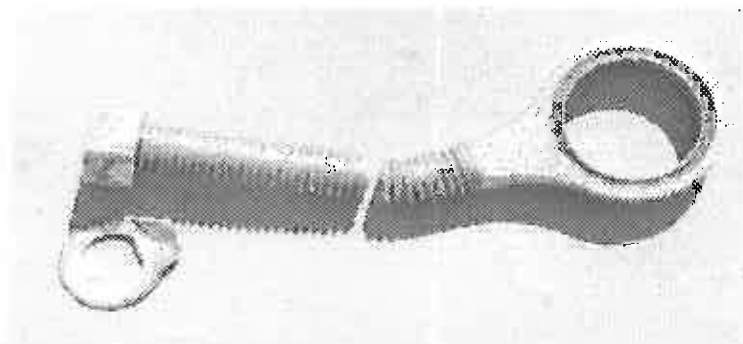
Continuing investigations indicate that the end bearing which failed was mechanically damaged well prior to the failure, and although not yet positively established, it is believed that the end bearing was bent by a person treading on the push rod or end bearing while entering or exiting the rear cockpit; not by loads imposed during flight.

Broken rod end bearing showing extent of bending prior to failure. Note profile of locktab to suit keyway.

4. Any suspect rod ends must be replaced with serviceable components before further flight.

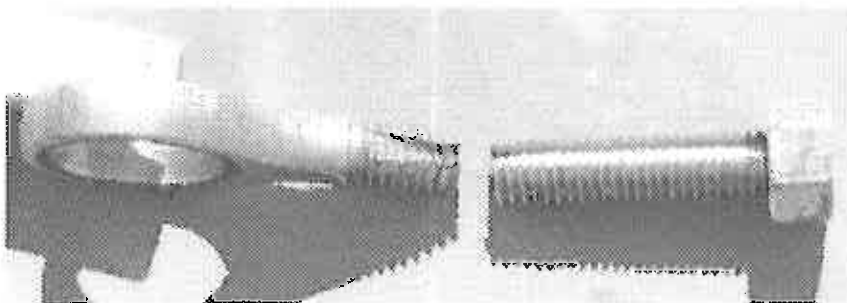
Accordingly, Issue 2 of this AD removes the requirement to disassemble all pushrod ends which have a keyway cut into the threaded portion (Item 3 of Action A, Issue 1). Metallurgy tests of the broken rod end are still underway.

Broken rod end bearing showing keyway.

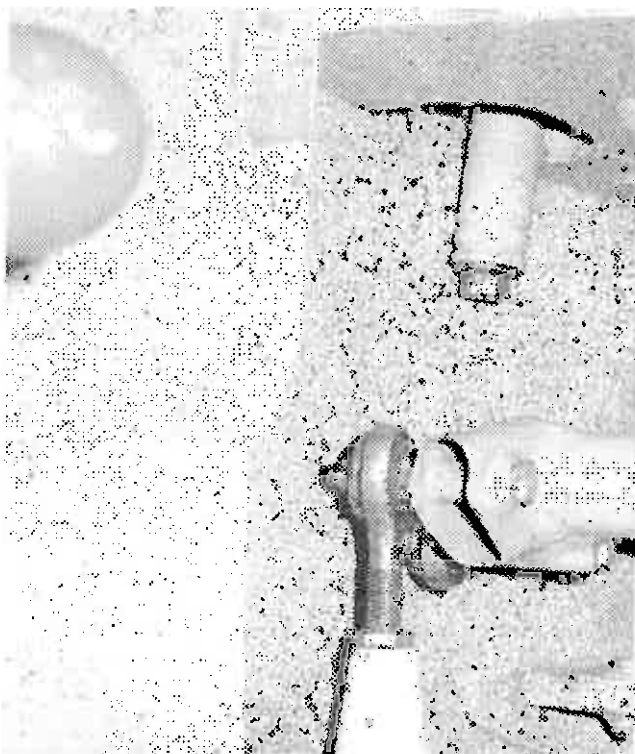
FINDINGS: On inspection it was found that the rear rod end bearing of the elevator pushrod which connects the front and rear control columns had broken at the point where the threaded portion enters the locknut. The pushrod was therefore completely detached from the rear stick.

View looking vertically downwards, left side of rear cockpit floor, showing edge of rear control column cross member and rear end of the elevator pushrod where the rod end bearing failed. Locknut and tab washer are still in place. Trim knob is visible in upper left of picture.

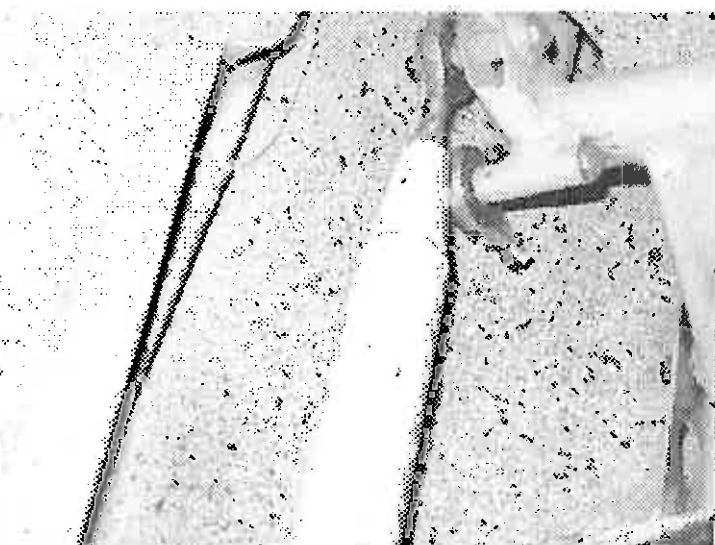
View from rear pilot's seat showing broken rod end bearing and its attachment point to the rear control column cross member.
