THE GLIDING FEDERATION OF AUSTRALIA

GFA AD-636
(ISSUE 1)

GFA AIRWORTHINESS DIRECTIVE

- TYPE AFFECTED:** STEMME S-10VT (Rotax 914 F2/S1 engine) Serial No's 11-001 up to & including 11-103.
- SUBJECT:** EXHAUST SYSTEM- INSPECTION FOR CRACKS.

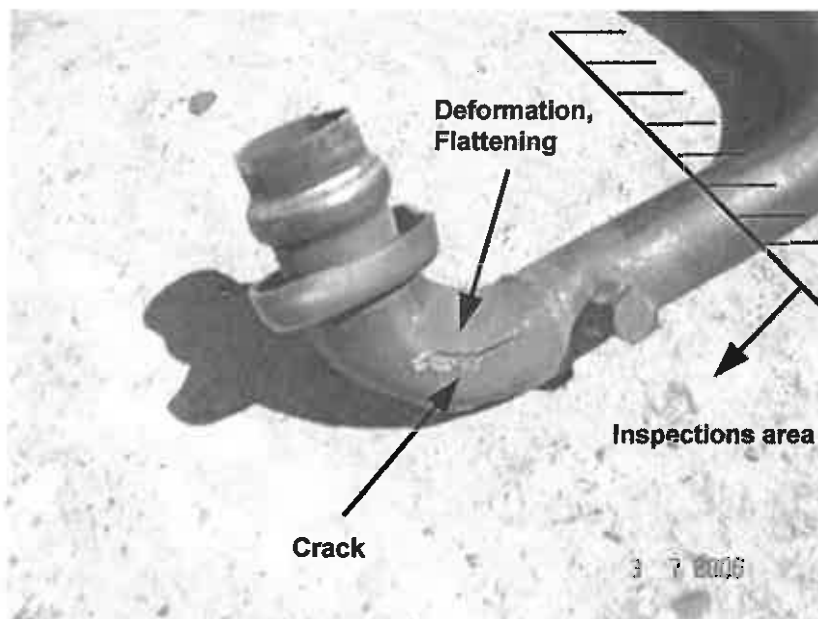
In an individual case deformations and cracks at an exhaust bend were found during maintenance work on the ROTAX 914 F2/S1. The defective exhaust bend was found on the thermally topmost loaded front-left cylinder. The damaged area is located in the curvature bend near the cylinder flange. Due to such a damage exhaust gases may expand into the engine compartment, or CO₂ may leak into the cockpit section.

One-time inspection of all exhaust bends (each cylinder 1 to 4) in the area of the curvature bend near the cylinder flange. Response of the findings to the manufacturer:

- Remove the heat protection wrapping in the area of the curvature bends.
- Visual inspection of the exhaust pipes for deformations, cracks and flattening.
- In case of damages replace the concerned exhaust pipes.
- Recondition the heat protection wrapping (use only material which is approved by the manufacturer, see AMM S10-VT)
- Response of the findings to the manufacturer (see attached form)
