GFA AD-638
(ISSUE 1)

GFA AIRWORTHINESS DIRECTIVE

SUBJECT: Cracks in Engine Mounting Pylon.

Technische Mitteilung Nr.
Technical Note No.
863 - 13 825 - 38

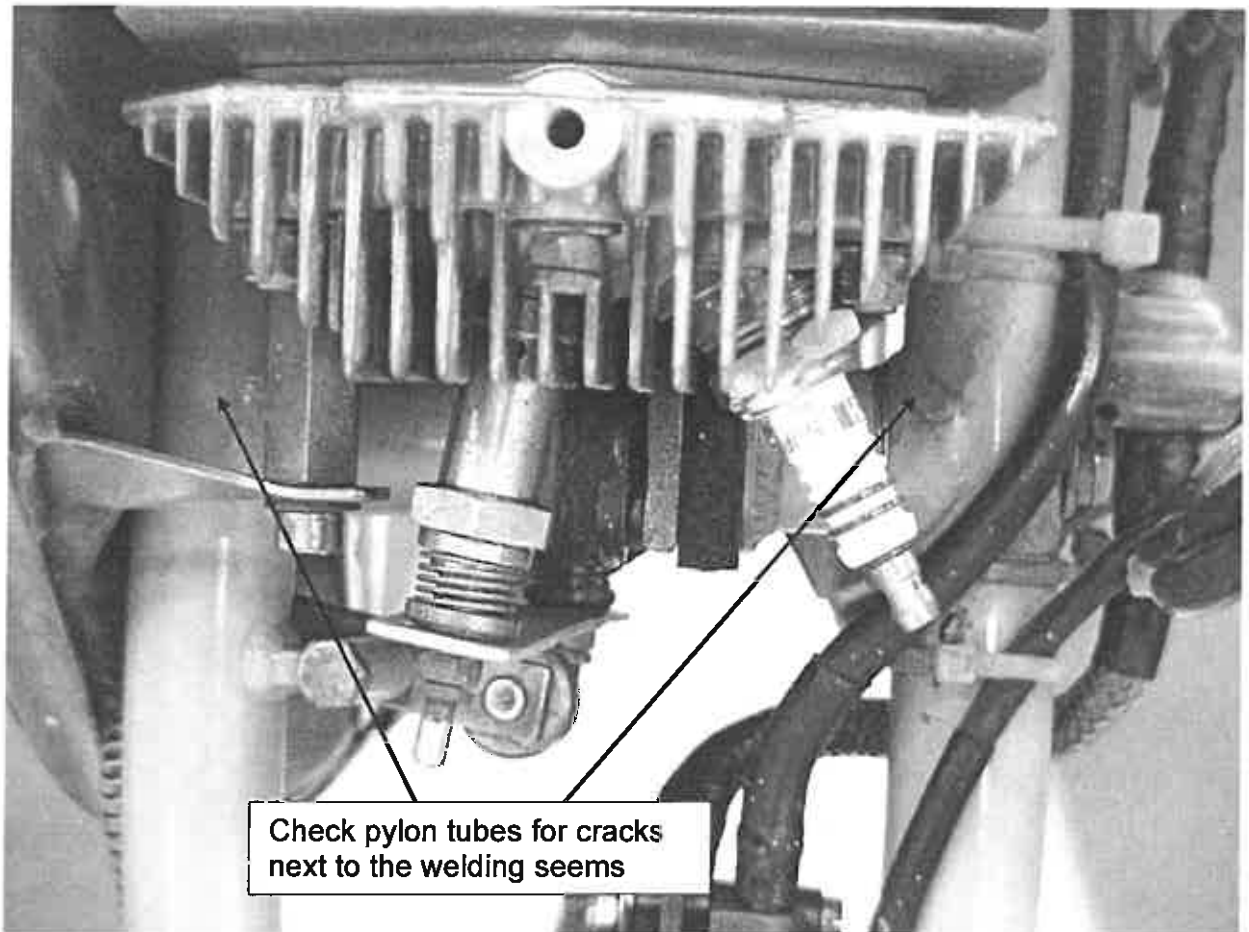
Front view of pylon

REASON: On a pylon cracks in the steel tubes next to welding seams were found. In advance
actions are taken to avoid further damage.

Check pylon tubes at the welding seams of the lower engine mount for cracks - see photographs enclosed to the Appendix of this Technical Note. Clean the affected areas at first if necessary.

If damage (cracking) is found, the pylon must be replaced. For this purpose the pylon must be removed and returned to the manufacturer. Please also forward the engine operation time of the affected pylon to the manufacturer.

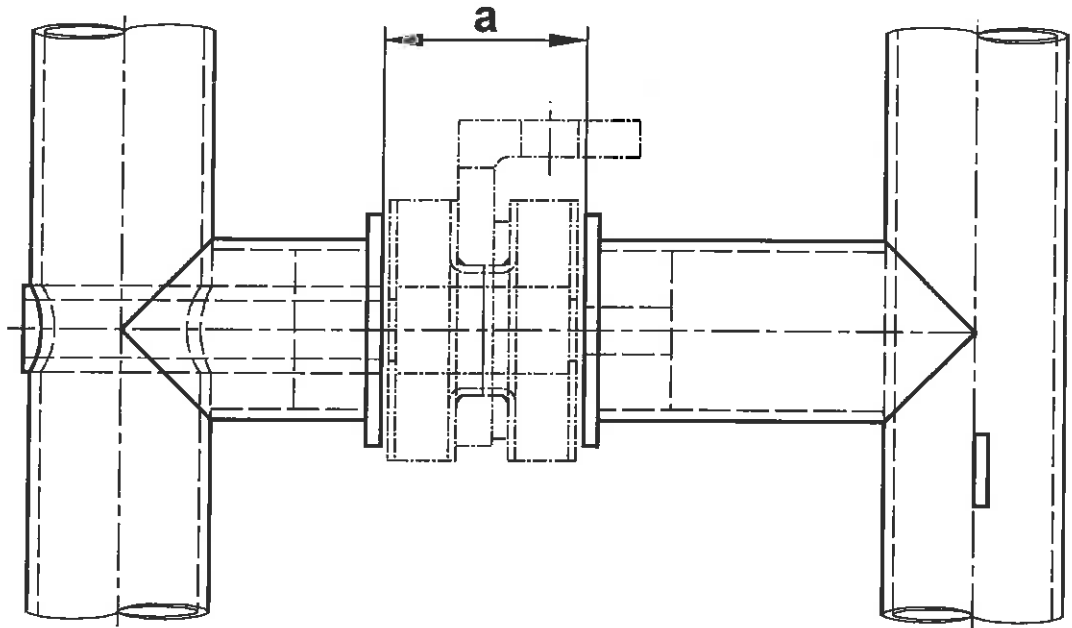
Skizze 1 / SKETCH 1

Sketch 1: Lower engine suspension, dimension „a“ between the pylon flanges (Rubber mount loose)

2. Determine the distance between the flanges of the pylon with a slide gauge (see sketch 1, dimension „a“). When measuring dimension „a“ the rubber mounts between the pylon flanges must be loose or may be compressed only slightly.
3. Now the gap between the pylon flanges and the rubber mounts is adjusted by fitting on both sides of the rubber mounts suitable spacers between the pylon flanges and the rubber mounts. The gap is adjusted in a way that after the lower engine suspension bolt is tightened the distance between the flanges is readjusted to the dimension „a“ from the released pylon.

Dimension „x“ = a-26,5mm („x“ = a-1.043 in.)	Thickness of the spacers to be installed:
2,0mm ≥ x > 1,5mm (0.0787 in. ≥ x > 0.05906 in.)	2 x 1,0 mm
1.5mm ≥ x > 1,0mm (0.05906 in. ≥ x > 0.03937 in.)	2 x 0,75mm
1.0mm ≥ x > 0,5mm (0.03937 in. ≥ x > 0.01969 in.)	1 x 1,0 mm, to be installed on the left hand side

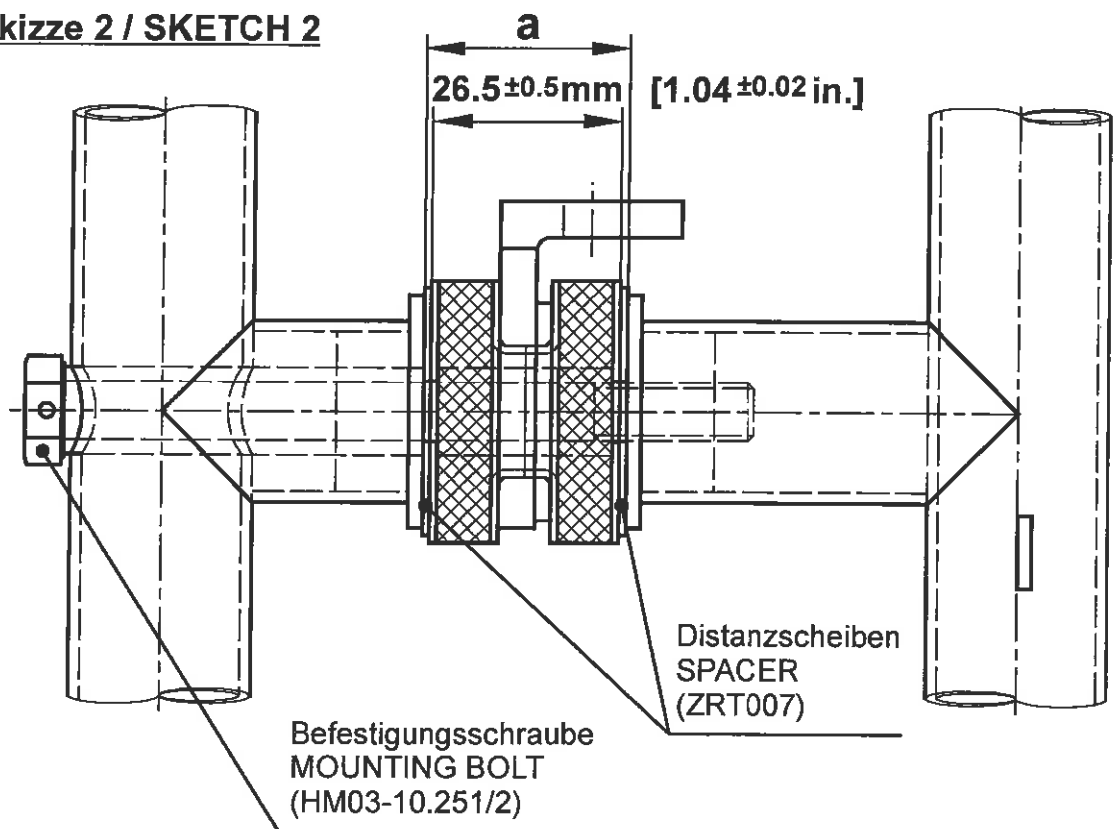
Skizze 2 / SKETCH 2

Sketch 2: Complete assembly of the lower engine suspension with spacers installed and suspension bolt tightened.

4. When the spacers have been installed insert the lower attachment bolt. Tighten the bolt so far that the rubber mount is compressed to the dimensions listed in the Flight Manual (s. sketch 2, dimension 26,5mm±0,5mm resp. 1.043in.±0.01969 in.):
