GFA AD-642
(ISSUE 1)

GFA AIRWORTHINESS DIRECTIVE

SUBJECT: Inspection of brass fuel connectors.

STEMME F & D DO: EASA.21J.250	Service Bulletin	Document Number: A31-10-077
	Fuel Connector – hose connector 10AB-75	Am.-Index: 01.a
		Page: 4 of 6

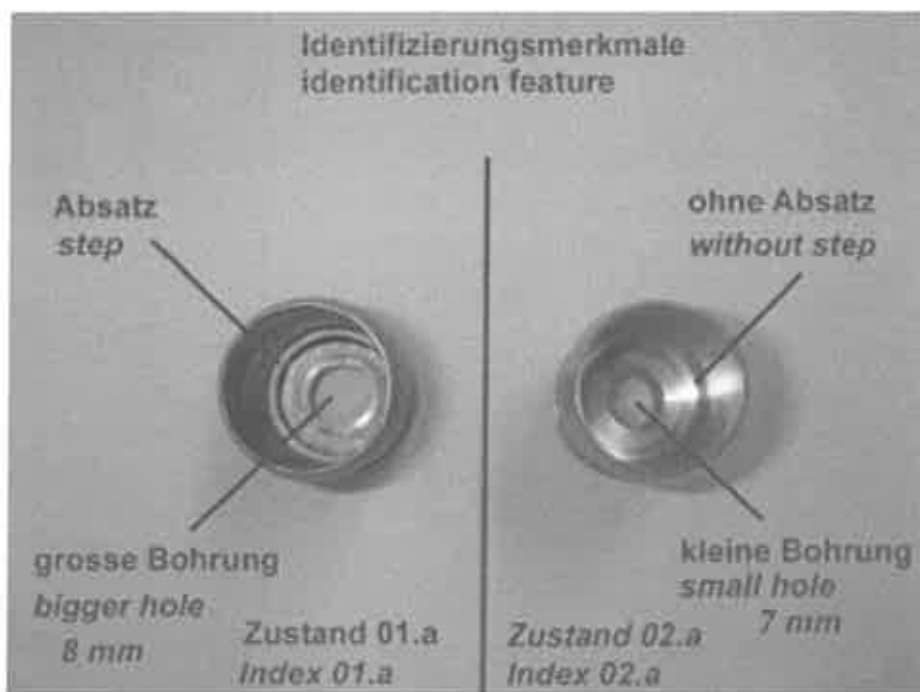
The leaking brass connector was according to the design modification index 01.a. It was valid for the period February 2002 until April 2002. A modified version of the hose connector was introduced in April 2002, after the old version turned out to be susceptible to improper assembly and maintenance work. The modified version has the design modification index 02.a.

- disconnect the quick-type fuel connectors between the wing and the fuselage
- If the fuel tanks are not empty, a second person should push down the wing to be inspected by hand. No fuel must be visible inside of the yellow "Tygon"-hose.
- unscrew the clamp for the hose connector 10AB-75
- visual identification of the design modification index of the hose connector according to the picture:

- if the **design modification index 01.a** will be identified: next step must be **action 3**.
- the existing fuel connector may be reassembled with the existing clamp if the design of the hose connector 10AB-75 confirms with modification index 02.a
- Inspection for tight mounting and leak tightness
- repeat action 2 (identification of installed version) for the other side of the wing
