GFA AD-645

GFA AIRWORTHINESS DIRECTIVE

TYPE AFFECTED: Grob G-109 & G 109B LBA TC 817 All Serial no's.

SUBJECT: Main Undercarriage Legs Inspection / replacement.

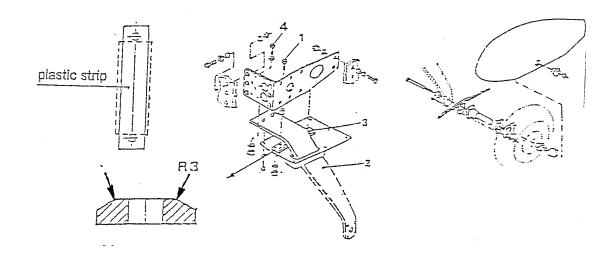
3. Check retaining bar (3) for a radius (minimum R3) (refer to arrow).

- 4. If the radius exists, a plastic strip P/N 109-5000.07 must be glued to the bars (refer to sketch) to restrict the risk of fretting. The glueing area must be cleaned and degreased.
- 5. If the bar has sharp edges (i.e. no radius), a new bar (P/N 109-5000.02) with plastic strip must be installed.

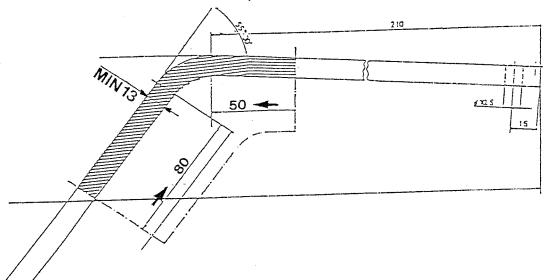
Pay attention only to remove the scaling coat. Do not cause additional scratches and grooves. Consider minimum thickness of 13 mm (refer also to workstep B.10.)!

8. Remove carefully and uniformly the scaling coat from the undercarriage leg (at the beginning use 60 grade emery paper, then use fine-grained paper up to grade 400).

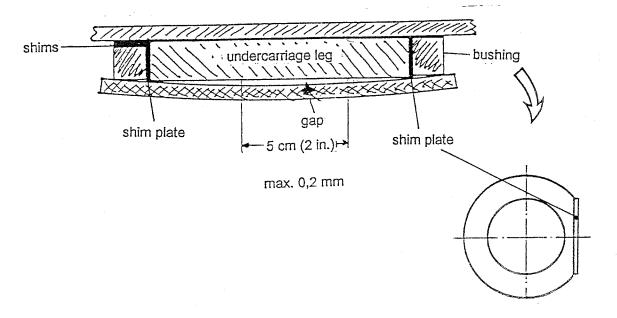
II. Pay attention, that no play is between undercarriage leg and bushing. Existing play must be removed as follows:

- glue shim plate P/N 109-5000.09, 1 mm thick, on to the bushing using Loctite 638 (curing time approx. 24 hours at room temperature and pressure, e.g. using a box clamp or a screw clamp)

- pay attention for a play free installation of the bushings, if necessary remove shim plate layers (each 0.05 mm) from front and rear bushing

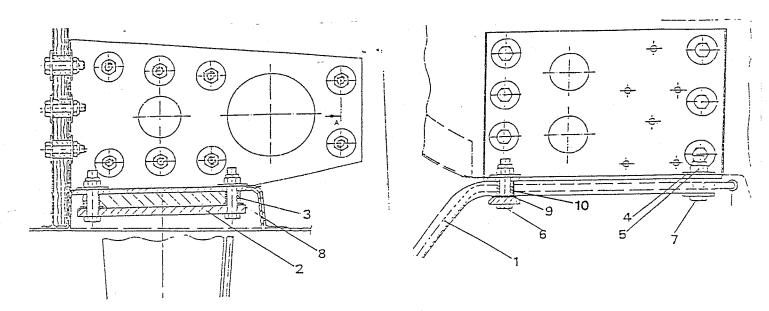
Direction of installation of screws (6) and (7):

- · G 109 all S/N's and G 109B, S/N 6200 6445: from bottom to top
- · G 109B, S/N as of 6500: from top to bottom
