GFA AIRWORTHINESS DIRECTIVE

- TYPE AFFECTED:** SZD-50-3 PUCHACZ:- All aircraft up to Serial No B-2207 and serial No's 503199327, 503A04001, 503A05002 & 503A05003
- SUBJECT:** Flight Controls: Inspection / replacement of airbrake intermediate (Vee shaped) bellcrank mounting bolt & lockwasher.

GFA AD-655 ISSUE 1 PAGE 2 OF 4

<p>Allstar PZL Glider Sp. z o. o.</p>	<p>SERVICE BULLETIN No BE-059/SZD-50-3/2007 "PUCHACZ"</p>	<p>Page: 2 of : 4</p>
<p>1. SUBJECT OF BULLETIN.</p> <p>1.1. Mandatory inspection of bolt of airbrake intermediate lever in wings. 1.2. Replacing washer and bolt mentioned above.</p> <p>2. GROUNDS OF ISSUANCE OF THIS BULLETIN.</p> <p>During pre-flight check in one of SZD-50-3 glider, it has been found impossible to fully retract/close the air brake on right hand wing, regardless from retracting successfully air brake on left hand wing and the brake lever in a cockpit locked in 'CLOSED' position. In glider inspection, unscrewing of the bolt, fastening an intermediate lever in air brake control from its seat has been found, regardless from having this locked with spring-lock washer. Further inspection detected, that bolt of intermediate lever in air brake control in le

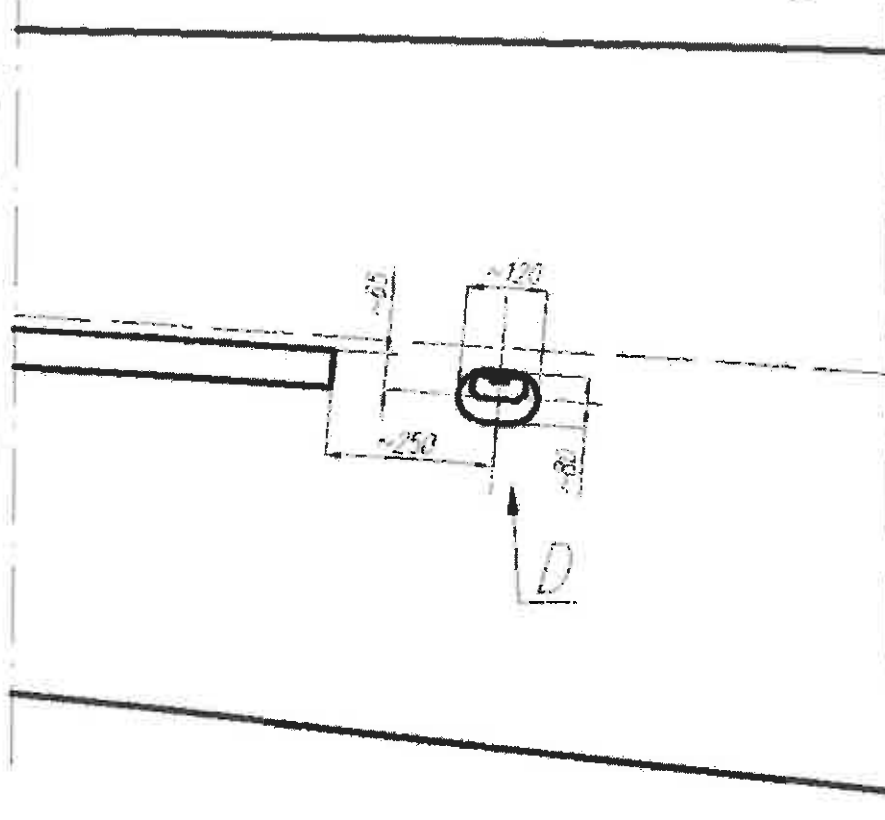
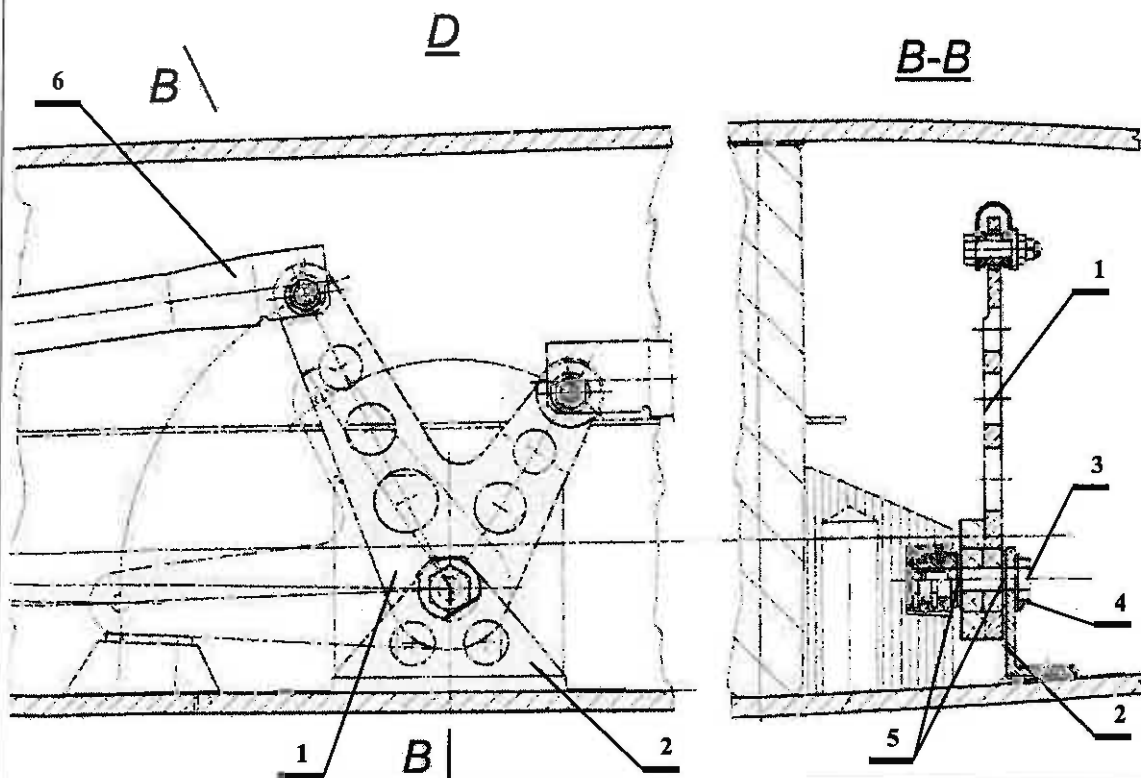
Fig. 1. Bolt and washer replacing.

- REASON:** Experience has shown that the mounting bolt in the right wing may become loose resulting in an inability to retract the airbrake on that wing. The left wing can be similarly affected although no instances of difficulty have been reported so far.

- ACTION REQUIRED:** In accordance with the above SB carry out the following actions.
ACTION 1. BEFORE FURTHER FLIGHT:- Inspect both wings for loose bolts securing the intermediate bellcranks. If any loose bolts are found, ***PRIOR TO THE NEXT FLIGHT*** BOTH M8x34 bolts must be replaced using M8x32 bolts, and the lockwashers must be replaced with locktabs. If no loose bolts are found, the aircraft may be returned to service provided that the inspection is repeated every 100 flying hours or 12 months whichever occurs first, until Action 2 has been accomplished.
ACTION 2. Unless performed as a result of Action 1, during the next 1000 hour inspection the M8x34 bolts must be replaced with M8x32 bolts and the split washers replaced with locktabs. It may be found more convenient to accomplish this at the next Form II.

<p style="text-align: center;">Allstar PZL Glider Sp. z o. o.</p>	<p style="text-align: center;">SERVICE BULLETIN No BE-059/SZD-50-3/2007 "PUCHACZ"</p>	<p style="text-align: right;">Page: 3 of : 4</p>
<p>6. REPLACING OF BOLTS AND WASHERS. Replacing of bolts and washers must be performed by certified maintenance organization.</p> <p>6.1. De-rig the wing.</p> <p>6.2. Cut a hole in upper skin of the wing, according to Fig. 1.</p> <p>6.3. Screw out and remove bolt M8x34, remove also spring-lock washer and spacer washers (5).</p> <p>6.4. Screw in bolt M8x32 (3), with a tab washer (4) as a locking device, inserting also spacer washers (5) on their place.</p> <p>6.5. Bend a tab of the tab washer (4) on the lever console (2) as shown in "D" view. Bend tab washer on the bolt (3) head, at arbitrary selected position.</p> <p>6.6. After ensuring that assembling has been performed correctly, and bolt reliably locked by tab washer bent, repair the hole in wing skin according to Repair Manual of the glider.</p> <p>7. PARTS NECESSARY FOR REPLACEMENT.</p> <p>7.1. Tab washers can be purchased from Allstar PZL Glider, or similar can be used, for example FABORY no. 51540 M8. Washer's tab is to be cut to 15 mm.</p> <p>7.2. Bolt M8x32 must be purchased from Allstar PZL Glider.</p> <p>8. FINAL CONCLUSIONS.</p> <p>8.1 Replacing of bolts and washers in accordance with point 6 of current bulletin is to be recorded at appropriate position in a Glider Log Book.</p> <p>8.2. For gliders verified during inspection as in point 5.1, introduce following revisions in Technical Service Manual (TSM):</p> <p>8.2.1. In TSM issue III, september 1980 and issue IV, may 981 in point 3.4. in column 'Maintenance work' in rows 'After every 100 flying hours' and 'On the end of flying season or before the prolonged hangaring' add 'Bulletin BE-059/SZD-50-3/2007'.</p> <p>8.2.2. In TSM issue I/JAR-22, may 1994 in point 15.7 in column 'Maintenance work' in row 'After every 100 flying hours' add 'Bulletin BE-059/SZD-50-3/2007'.</p> <p>8.2.3. Introduced revisions must be recorded in Record of Revisions in TSM..</p> <p>8.2.4. After replacing bolts and washers according to point 6 of current bulletin, cancel revisions recorded according to points 8.2.1. or 8.2.2. Cancellation must be recorded in Record of Revisions in TSM.</p> <p>8.3. If loosen bolt is detected, Operator of the glider is requested to notify Allstar PZL Glider on this fact, specifying: Serial Number of glider, total flight time, number of landings, and Operator/Owner data.</p> <p>8.4. The operator is introducing this Bulletin at his own cost.</p> <p>9. DESCRIPTION OF FIG. 1.</p> <p>1- intermediate lever in airbrake control system</p> <p>2- lever's console</p> <p>3- M8x32 bolt</p> <p>4- tab washer</p> <p>5- 8,5x1 washer</p> <p>6- pushrod</p>
