## GFA AIRWORTHINESS DIRECTIVE

**TYPE AFFECTED:** DG-100 Series sailplanes TCDS LBA 301

**SUBJECT:** Flight Controls, Inspection / Modification:- Elevator Control Bearing Stand.

Technical note  
No. 301/26

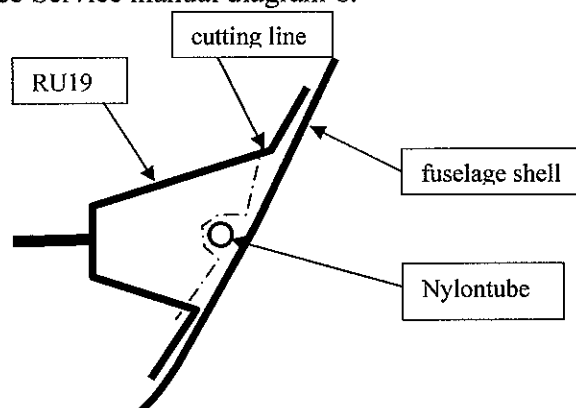
4. Abrade the brink of the bearing stand until the fibreglass of the brink is completely removed and the Nylon tube is free, use a high speed grinder.

5. Sand the gluing surface of the new bearing stand and glue the stand to the same place. First apply resin/hardener to the gluing surfaces. Then mix resin/hardener with cotton flocks and apply to the stand. Press the stand to the fuselage wall and secure against slipping out of place.  
DG-100 with all flying tailplane: If the Nylon tube went through the stand make cut outs in the new stand for the tubes. Sand the stand min. 30 mm (1.2 in.) around the cut outs. Place the tube in the cut outs when gluing the stand to the fuselage shell. Lay glasfibre fabric 3x92125 above these areas after postionong the stand.

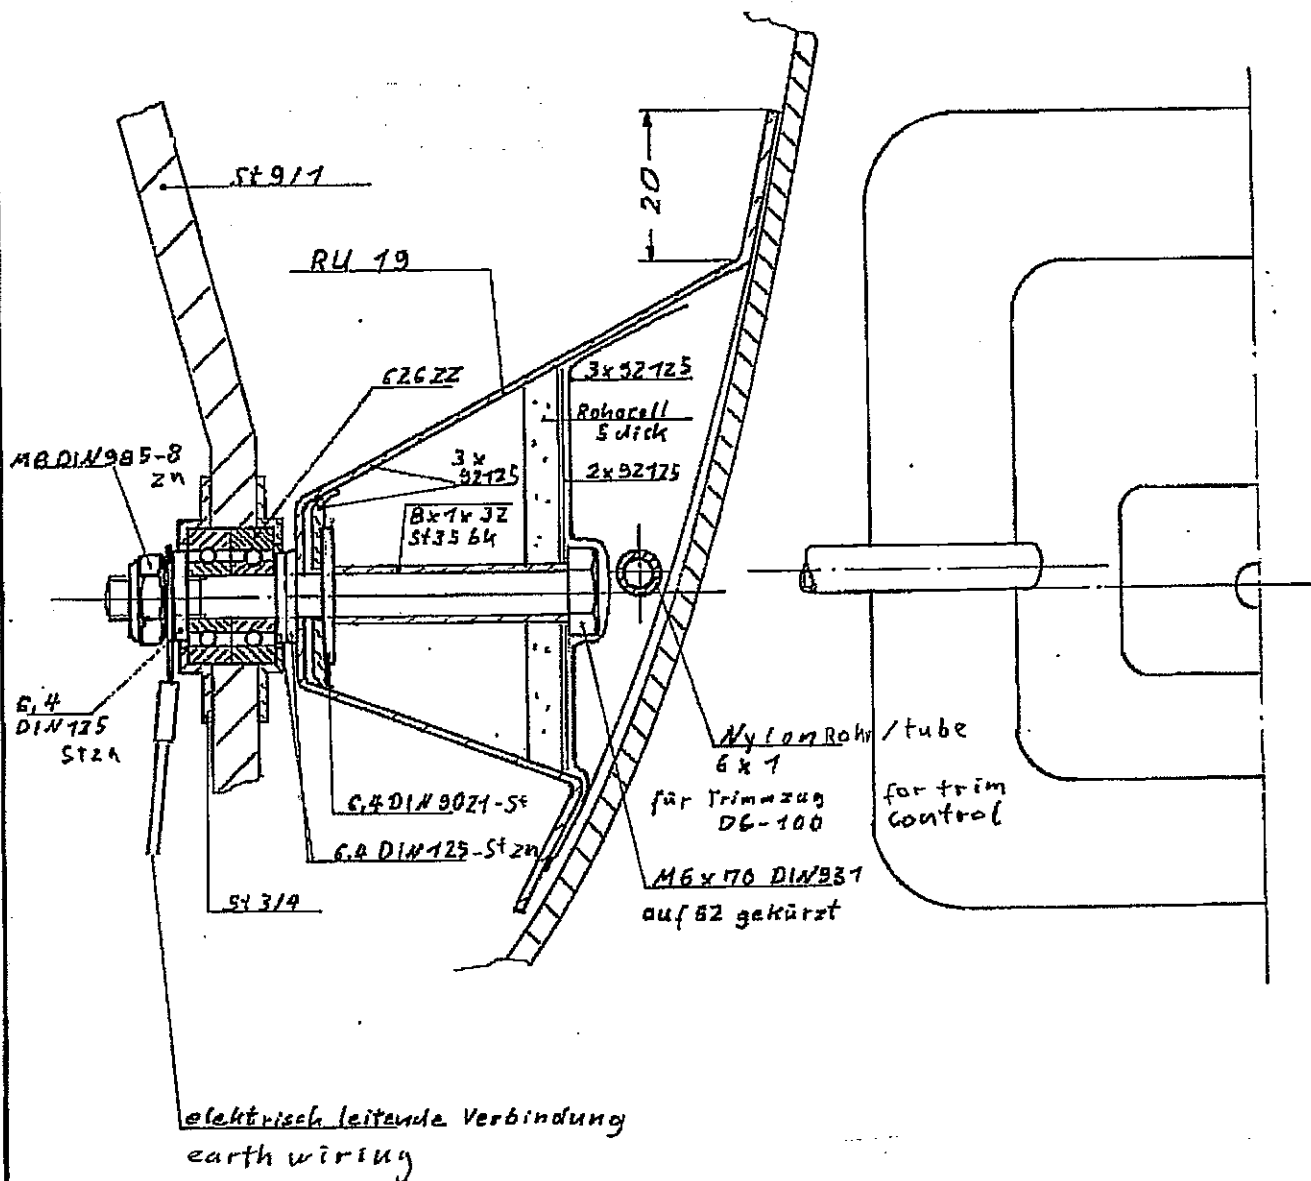
St 9 a

Installation elevator control bellcrank, fuselage centre
