GFA AIRWORTHINESS DIRECTIVE

Technical note
No. 800/36, 843/30

- Subject : Starter ring gear for Solo 2625 01 and 2625 02, zinc coated version
- Effectivity : DG-800B and DG-500MB with zinc coated starter ring gears

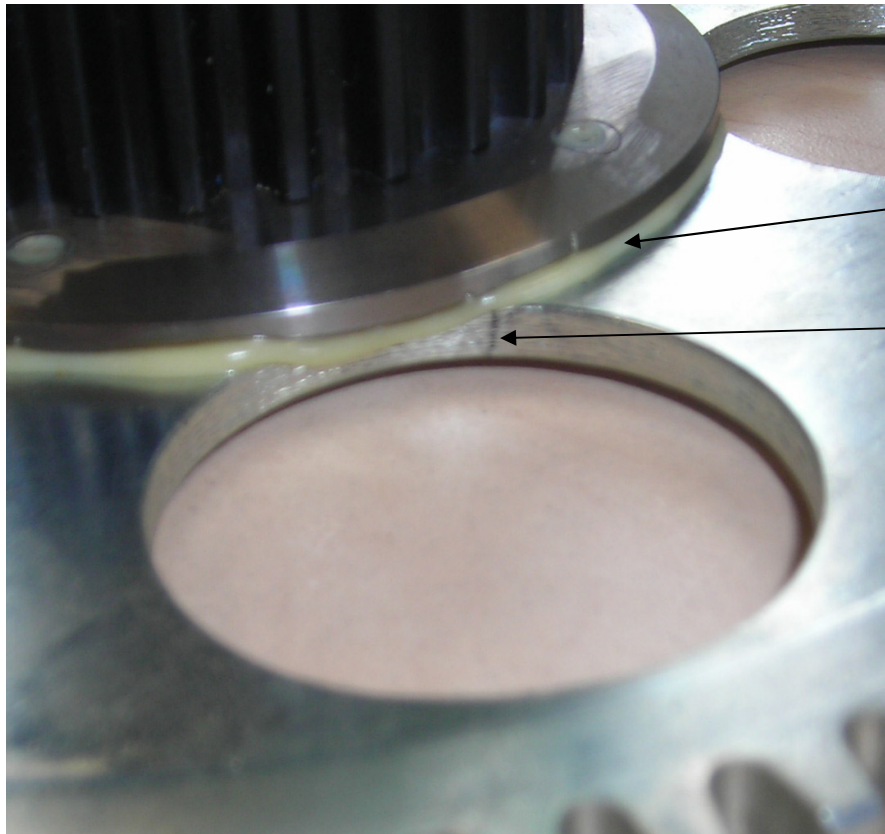
- Accomplishment : 1. Prior to next take-off
2. At each pre-flight inspection
3. If cracks have been detected exchange prior to next use of engine
- Reason : One of the zinc coated ring gears cracked and the escaping parts caused severe damage to the starter motor, the engine mount and the drive belt.
To date no reports of cracking have been received on the painted starter ring gears, which have been in service much longer than the zinc coated type. It is the manufacturers opinion that the zinc plating process may cause Hydrogen embrittlement which may encourage cracking.

crack in starter ring gear

- Instructions : 1. Determine if the starter ring gear is zinc coated or painted. Painted starter ring gears are not affected by this TN.
2. During each pre-flight inspection extend the powerplant just so far, that you can turn the propeller. Clean the lightening holes in the starter ring gear with a piece of cloth soaked with Acetone or cleaning benzine. Check for cracks see photo on page 2.

3. If cracks are visible the starter ring gear must be exchanged prior to next use of the engine. To accomplish this the starter ring gear assembled with adapter and lower drive belt pulley must be removed from the engine according to MM DG-800B and DG-500MB section 4.16.2 item 3, DG-808C section 4.17.2 item 3 and ship the assembly to DG Flugzeugbau for modification.
