AIRWORTHINESS ADVICE NOTICE

GFA/AN 69

TYPE AFFECTED: All sailplanes and powered sailplanes originally externally finished in "Vorgelat" gel coat.

SUBJECT: Gel coat failure, its removal, replacement and care.

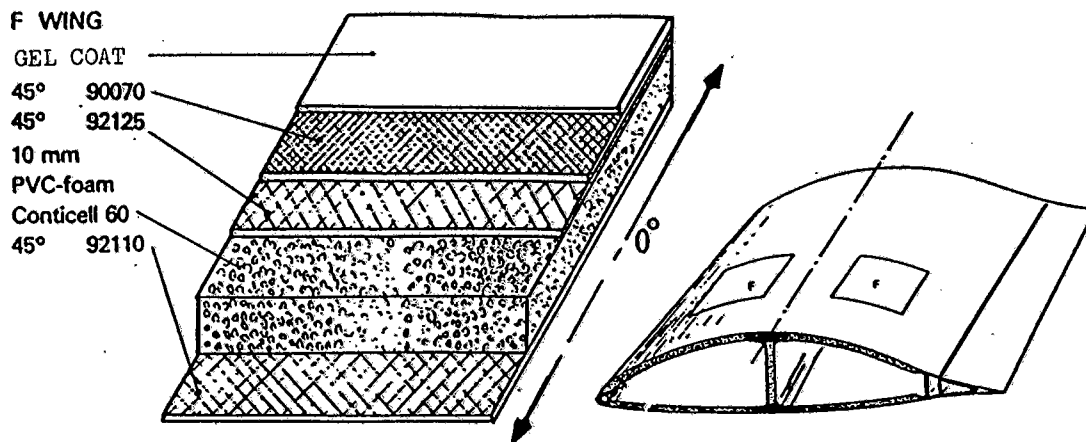
Before attempting to replace gel coat, the structure of the sailplane must be clearly understood, particularly wings, tailplanes and control surfaces, all of which have very thin structural skins.

This is a typical wing section.

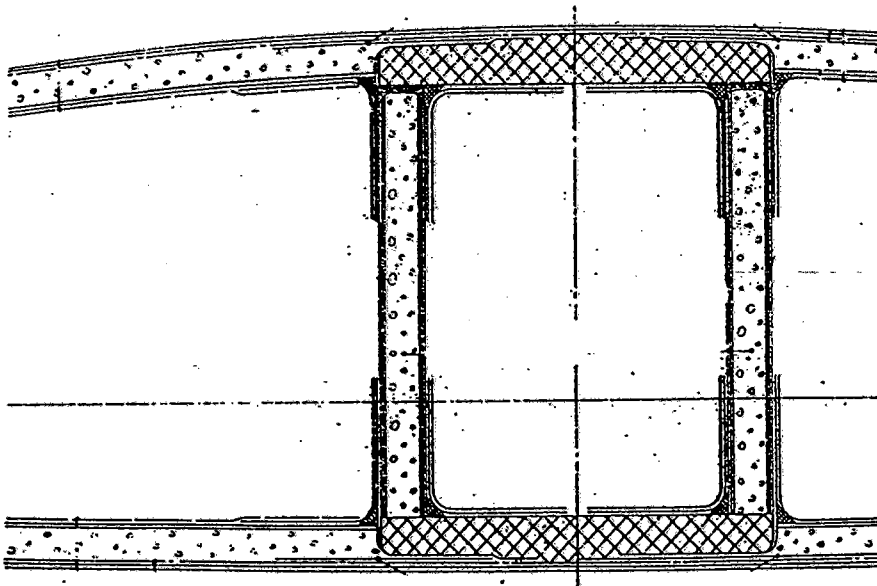
BOX SPAR.

This Carbon Roving Box Spar extends out to the outer skin layer. The wing skins forward, over and rearward of the spar have extra layers of Glass or Carbon fabric for local load distribution and contour stability.

- The glass/epoxy layer is very thin and quite flexible.
- The gel coat varies considerably in its thickness, and is very stiff.
- Unless a manufacturer says so there is no "sacrificial layer" on the outside of wing or tailplane shells.

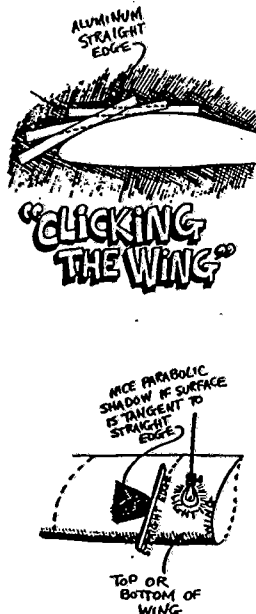
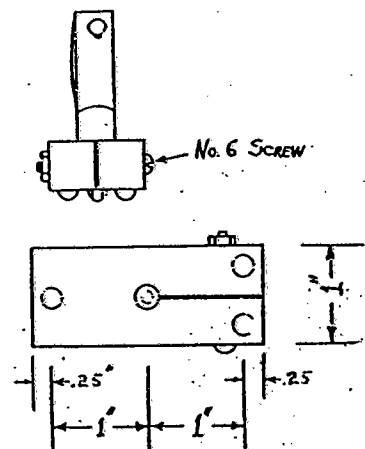
"CLICKING" THE WING;

These illustrations show another method of checking the wing surface for smoothness. Sanding boards of various lengths allow the surface to be roughed down to approximate shape, final sanding done with an aluminium or steel straight edge which will make a slight clicking sound as it rocks over a flat spot, the light also throws a shadow that indicates a flat spot.
