# THE GLIDING FEDERATION OF AUSTRALIA

## AIRWORTHINESS ADVICE NOTICE GLIDER/POWERED SAILPLANE

GFA/AN 57

SUBJECT: The likelihood of winch or aerotow cables catching on tailskids and other protrudances.

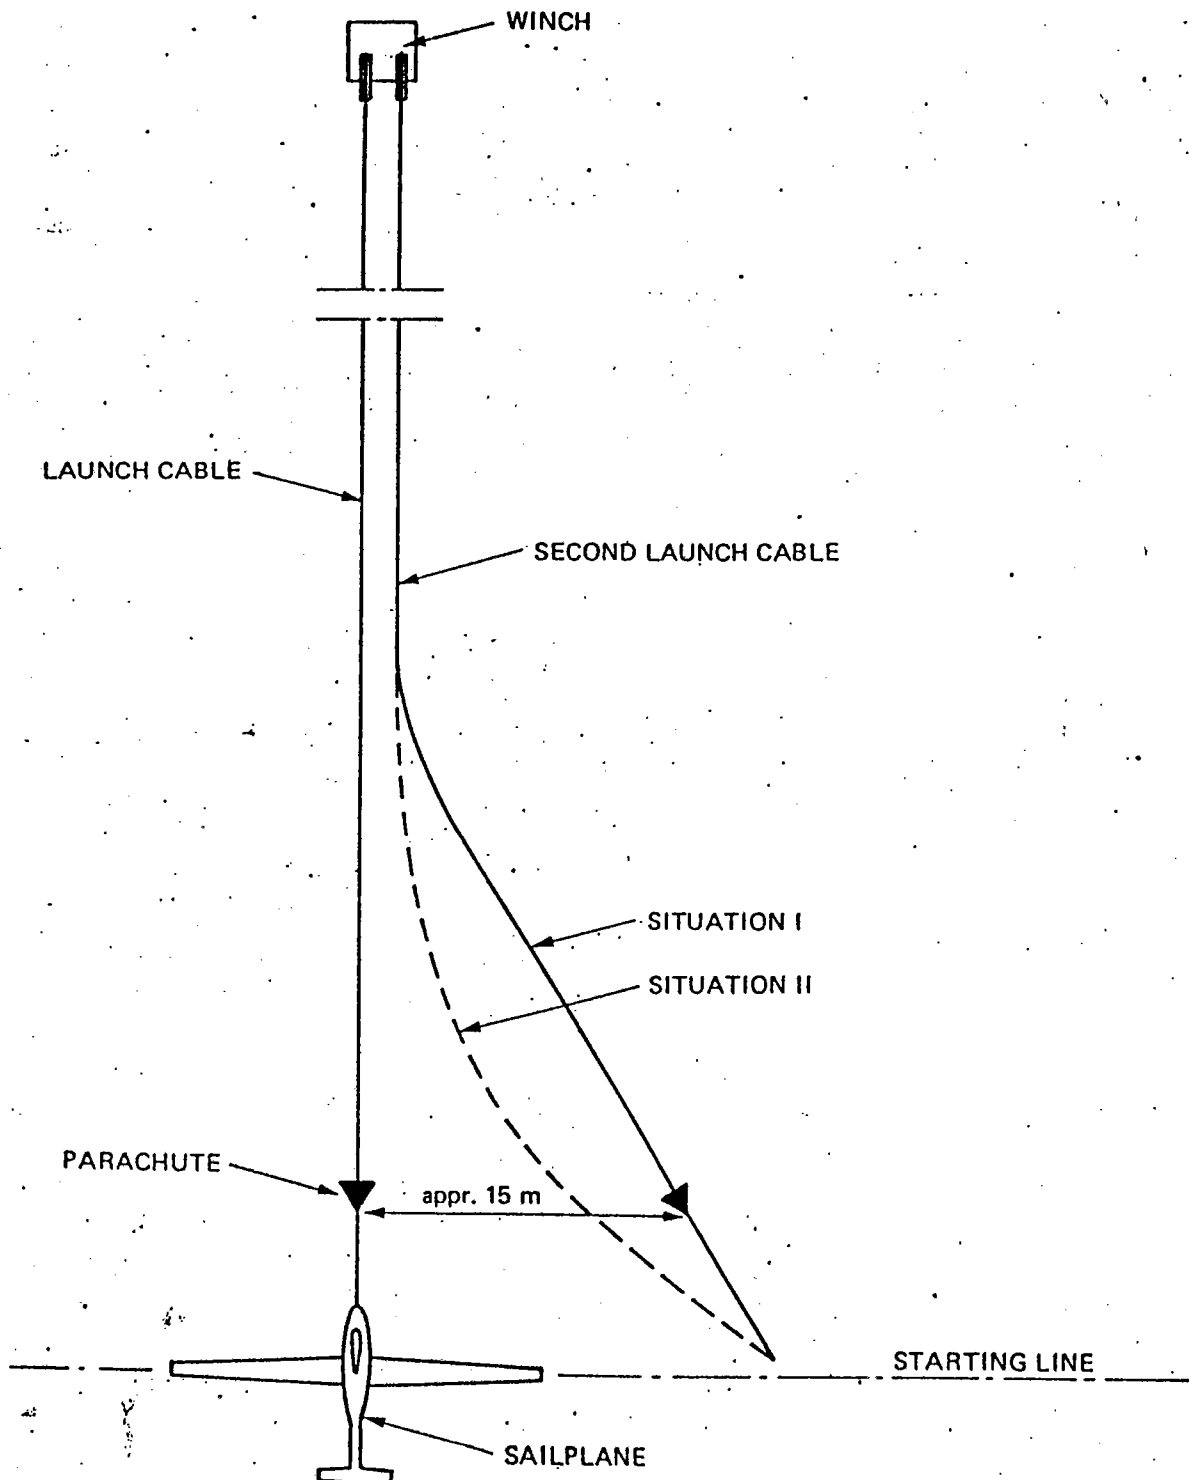
Fig. 1 Location of launch cables during a winch start

The accident occurs when two (or more) cables are laid along each other from the winch to the take off position of the sailplane, see figure 1. In normal sailplane operation the second launch cable will be pulled aside. Care should be taken that the distance between both cables has been increased sufficiently.

At the location of the starting line one can think of about 15 metres. In the direction to the winch the distance between the two cables should not decrease too rapidly as is indicated in figure 1 (situation II). This may easily occur if the grass is very long or the field is very rough.

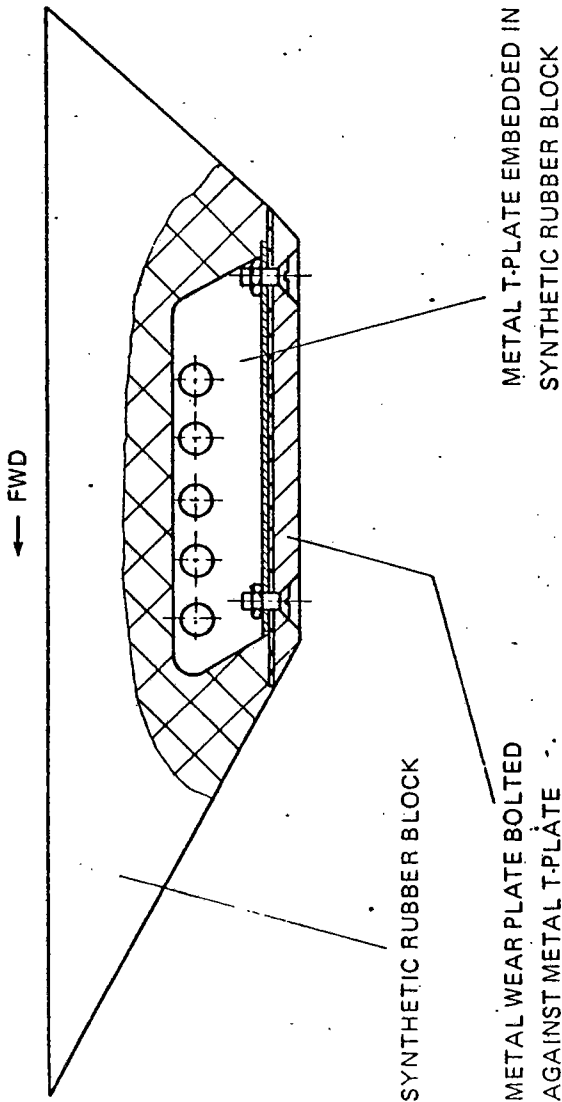
Fig. 6 Tail skid construction of Grob sailplanes (Astir)

A sketch of the construction is given in figure 6. Shock absorbtion is obtained by means of a synthetic rubber block.

It was found that the density of the synthetic rubber block is not the same for the different sailplane types.
