The Gliding Federation of Australia Inc

Occurrence Summaries

01/01/2013 to 31/12/2013

Accident and Incident Summaries

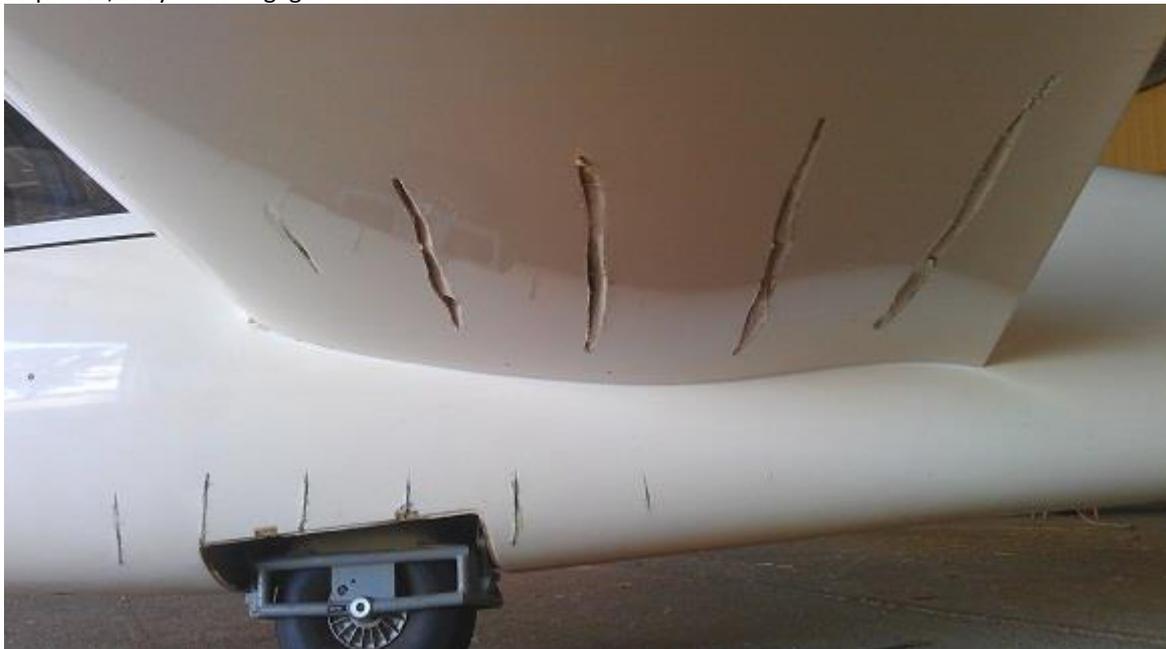
Both gliding clubs operated under the rules and procedures proscribed by the Gliding Federation of Australia (GFA). The investigation conducted by the GFA determined that glider and tug landed together with the glider on top. Propeller strikes caused damage to the underside of the glider's left wing and along the fuselage near the main landing wheel. There was no damage to the C150. The GFA investigation determined

that the glider tug and glider would have been operating at similar speeds, on simultaneous final approach aiming to land on the same runway, using a similar aiming point. The restricted visibility from both cockpits would have resulted in neither pilot being aware of the other. The GFA investigation also noted: *"While the pilot of both aircraft made appropriate broadcasts on the CTAF, it is possible the radio transmissions tug to glider were not heard due to proximity interference. Frequency congestion from the aerobatic operations may also have impeded situational awareness."*

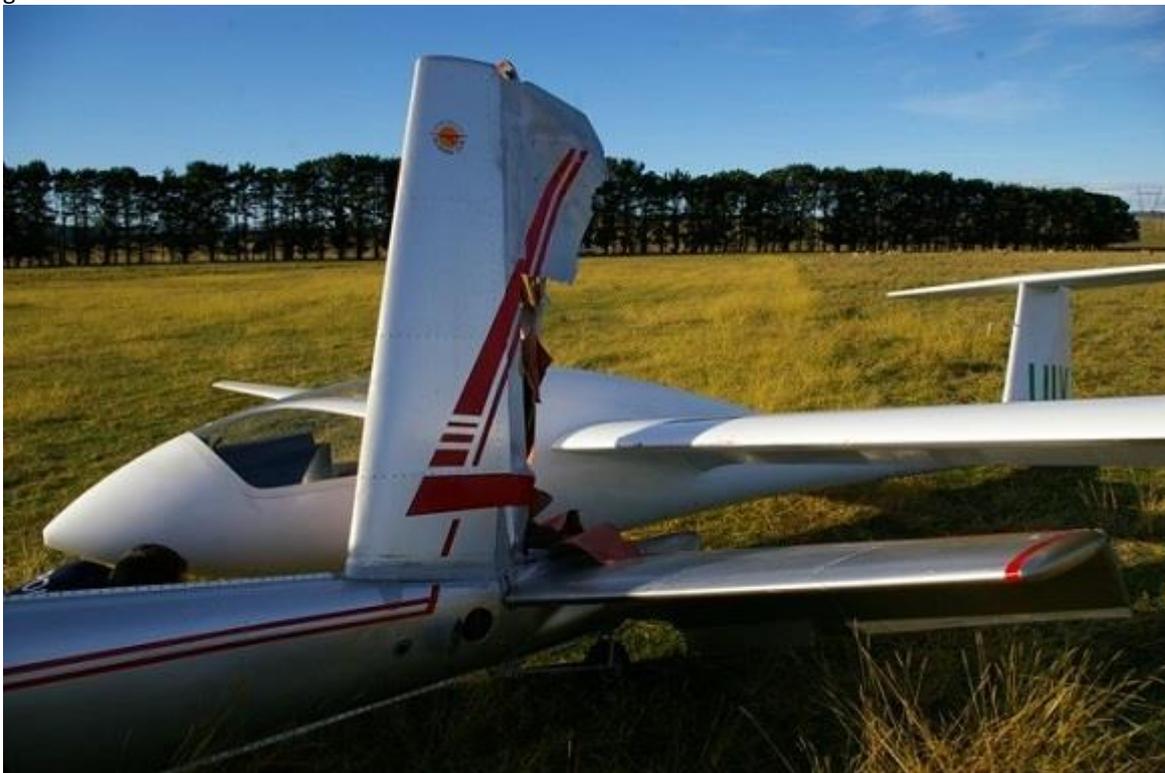
Ground Impact Damage Views of Blanik

departure call from the Blanik." He then stated, "As I turned onto finals, I lined up with the runway at about 300 ft above ground level. I didn't see the Blanik at any stage as I crossed over the pine trees at about 100ft, giving me a 50ft clearance from the top of the trees." During final approach, the data logger was recording position and altitude at 4 second intervals, until the glider executed a major positive vertical acceleration at 1541:46 seconds, about 12 seconds after being established on approach. The data shows the glider descending quite rapidly, then at about 89ft QFE suddenly rapidly accelerating upwards. Impact probably occurred at about this point. Two seconds later, at 1541:48 seconds, the glider appeared to be at 200 ft QFE, a rise of over 110ft from the previous data point. The data then shows the glider descending and landing ahead on Runway 23. The sudden vertical acceleration and temporary altitude gain appears to correspond to the combination of an instinctive reaction to try to avoid a collision, along with the nose of the Mini-Nimbus being pitched up by the Blanik tailplane. On the evening of the accident, the Command Pilot's verbal account to the GFA Accident Investigator emphasised that "I saw the winch rope rising in front of me, the same time the fuselage of the Blanik appeared, climbing right beside me to the left of the cockpit, and an instant later there was a bang as we collided. There was no time to avoid; everything happened in a fraction of a second." The Command Pilot's written account included these statements: "I could not see the Blanik because of my own fuselage. In my mind the runway was clear to land. Then almost simultaneously I observed the winch rope lifting off the ground and the Blanik's fuselage appeared about 1 metre to the left of my fuselage and I heard a loud report "bang" as the two aircraft collided. At the time of the collision I was about 10 degrees nose down and the Blanik was about 30 degrees nose up. I was descending rapidly with full dive brakes and he was climbing rapidly. The Blanik then disappeared." With the combined vertical rates of the descending Mini-Nimbus and ascending Blanik, plus aerodynamics limitations and inertial effects coupled with blind arc limitations in the cockpits of both gliders, the time available from a late visual detection of the threat to avoidance of a collision would have been miniscule. It appears that the collision would have been almost impossible to avoid once the winch launch had commenced below the landing glider.

limited positions on the base leg. It was not visible on the final approach path. With a flight path corresponding to a moderate approach on Runway 23 and 50ft obstacle clearance over the pine trees, the first 75 metres of the runway were not visible for much of the approach, due to obscuration by the trees. A shallower or flatter approach path would cause the trees to have obscured more of the runway length. The Blanik crash site was about 150 metres from the launch point. When the Mini-Nimbus was passing over the pine trees, the glider blind arcs forwards and below would have obscured the launch point and Blanik from view. A displaced threshold for the launch point, more distant from the pine trees, would have been required to reduce their apparent elevation. This was compounded by operational decisions made that day that did not achieve required separation of launching and landing operations. The operations crew did not use an alternate, laterally displaced landing area such as Runway 23 Left, due to long grass growth, infrequent mowing and presence of stock; and also conducted both launches and landings from the same runway, without a displaced threshold that might have improved visibility of other gliders in the circuit area.
