The Gliding Federation of Australia Inc

Occurrence Summaries

01/01/2021 to 31/12/2021

The Gliding Federation of Australia Inc
SOAR Accident and Incident Occurrences

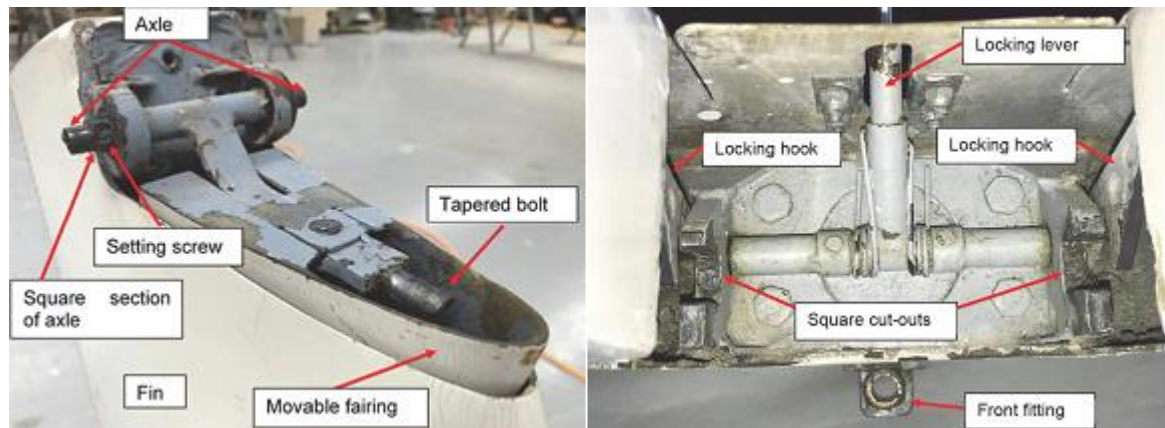
Figure 1. Standard Cirrus 75 tailplane attachment fitting at top of fin (left image), and tailplane attachment mechanism - view looking forward (right image).

When the pilot rigged the tailplane, he did not push the locking lever sufficiently aft to lock the mechanism and inserted the safety pin behind the locking lever. This resulted in the rear mechanism being engaged but not locked, as the pin prevented the lever from travelling aft to the fully locked position (Figure 3). In this condition the locking hooks were not fully engaged on the axle but the tailplane felt secure and could not be dislodged.

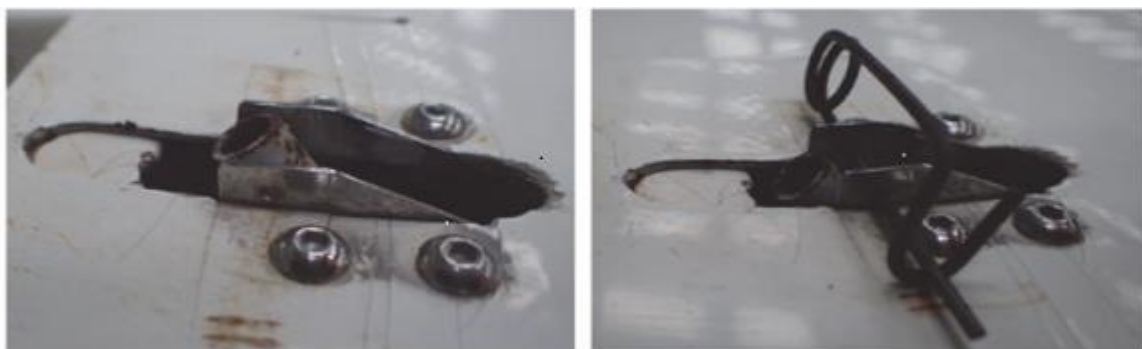
Figure 2. Locking lever when tailplane attached (left image) and when locked with safety pin inserted (right image)

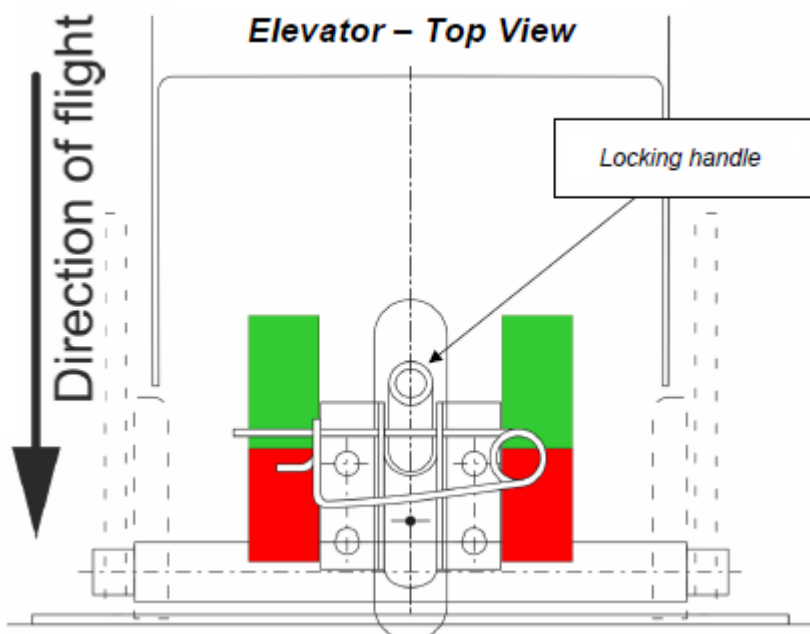
- if the locking handle is in the red area, then the elevator is not correctly locked
- if the locking handle is in the green area, then the elevator is correctly locked'

Figure 4. Colour markings

On 07 August 2020 the glider manufacturer, Schempp Hirth, issued Technical Note 278-40 dealing with the application of colour markings for the elevator attachment and updated manual pages. The colour markings (Figure 4) provide a visual indication of the correct locking of the elevator attachment, viz.:

On 10 December 2020, EASA issued Airworthiness Directive AD No.2020-0260 requiring an optical indicator to be applied in accordance with the instructions of the Schempp Hirth Technical Note within 90 days from the AD issue date.

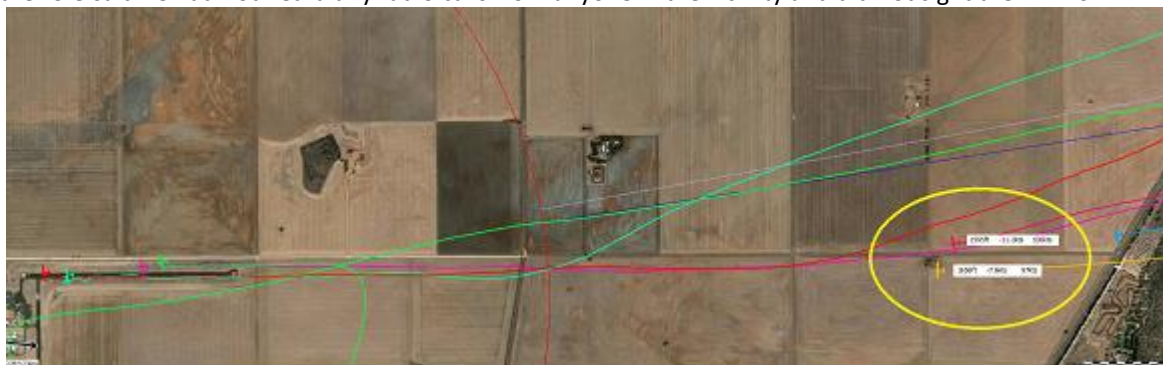
Fig. 1 Satellite image showing the position of several competing gliders at time of incident. The two gliders in conflict are circled.

Review of the flight traces for all gliders competing at the time revealed there were four gliders occupying the runway as the PIK-20 and LS-8 were on approach (refer Fig 1). The PIK-20 pilot would not have seen the LS-8, as it was converging from below and behind and outside his field of view (refer Fig 2). On the other hand, the pilot of the LS-8 should have been able to sight the PIK-20, which was ahead and higher, but did not. It is likely the LS-8 pilot had focussed his attention on the runway and where he was going to land. The incident was debriefed with the Competition Safety Officer and discussed at the following morning's safety briefing.

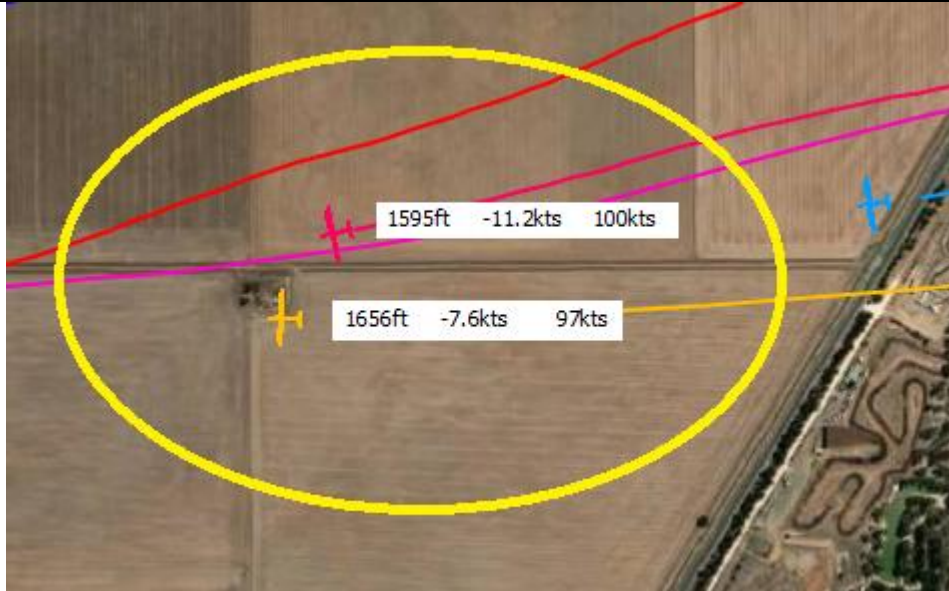
Fig. 2 Proximity, height, sink rate and speed of the two conflicting gliders. The LS-8 is converging on the PIK-20 from the right.

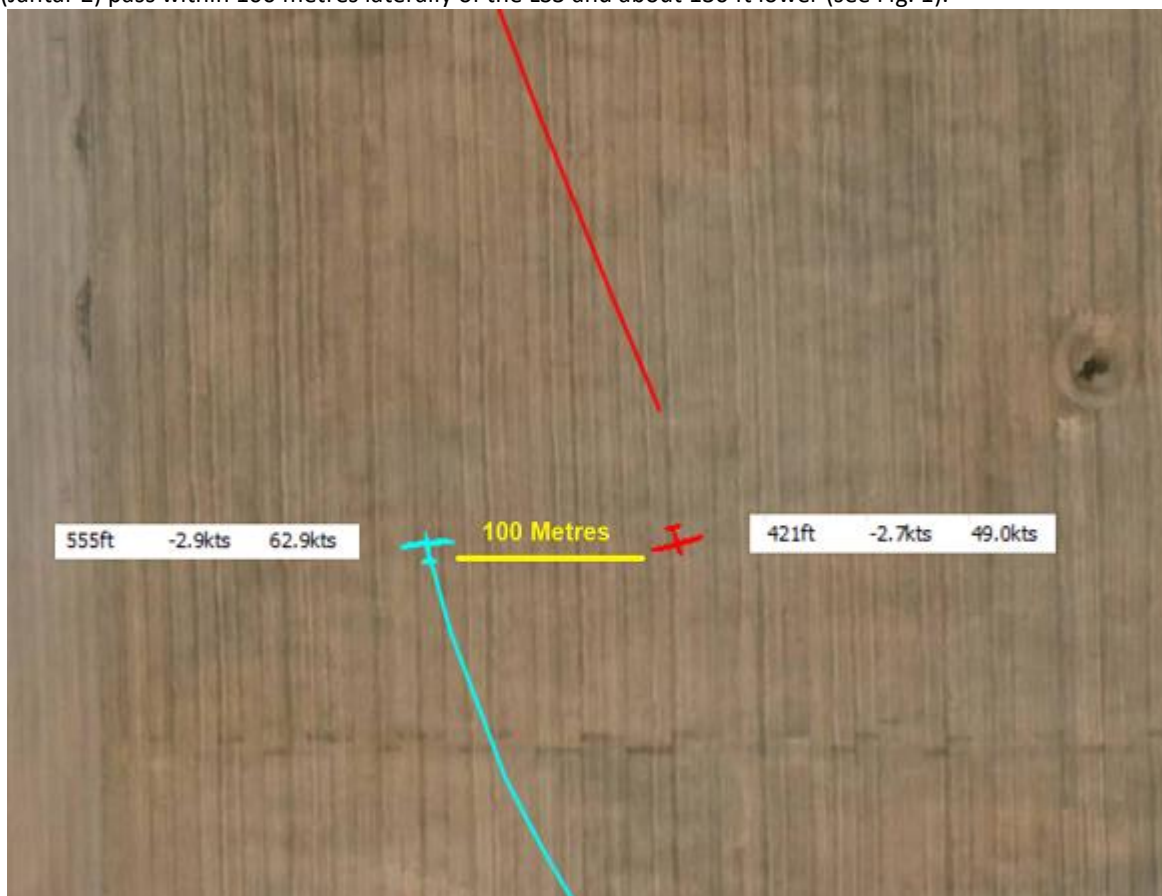
While on the final glide of a competition task and about 1km short of the finish circle, the pilot of an LS3 elected to conduct an outlanding. As the pilot turned onto their downwind leg, they observed another glider (Jantar 2) pass within 100 metres laterally of the LS3 and about 130 ft lower (see Fig. 1).

Figure 1. Proximity determined from logger traces.

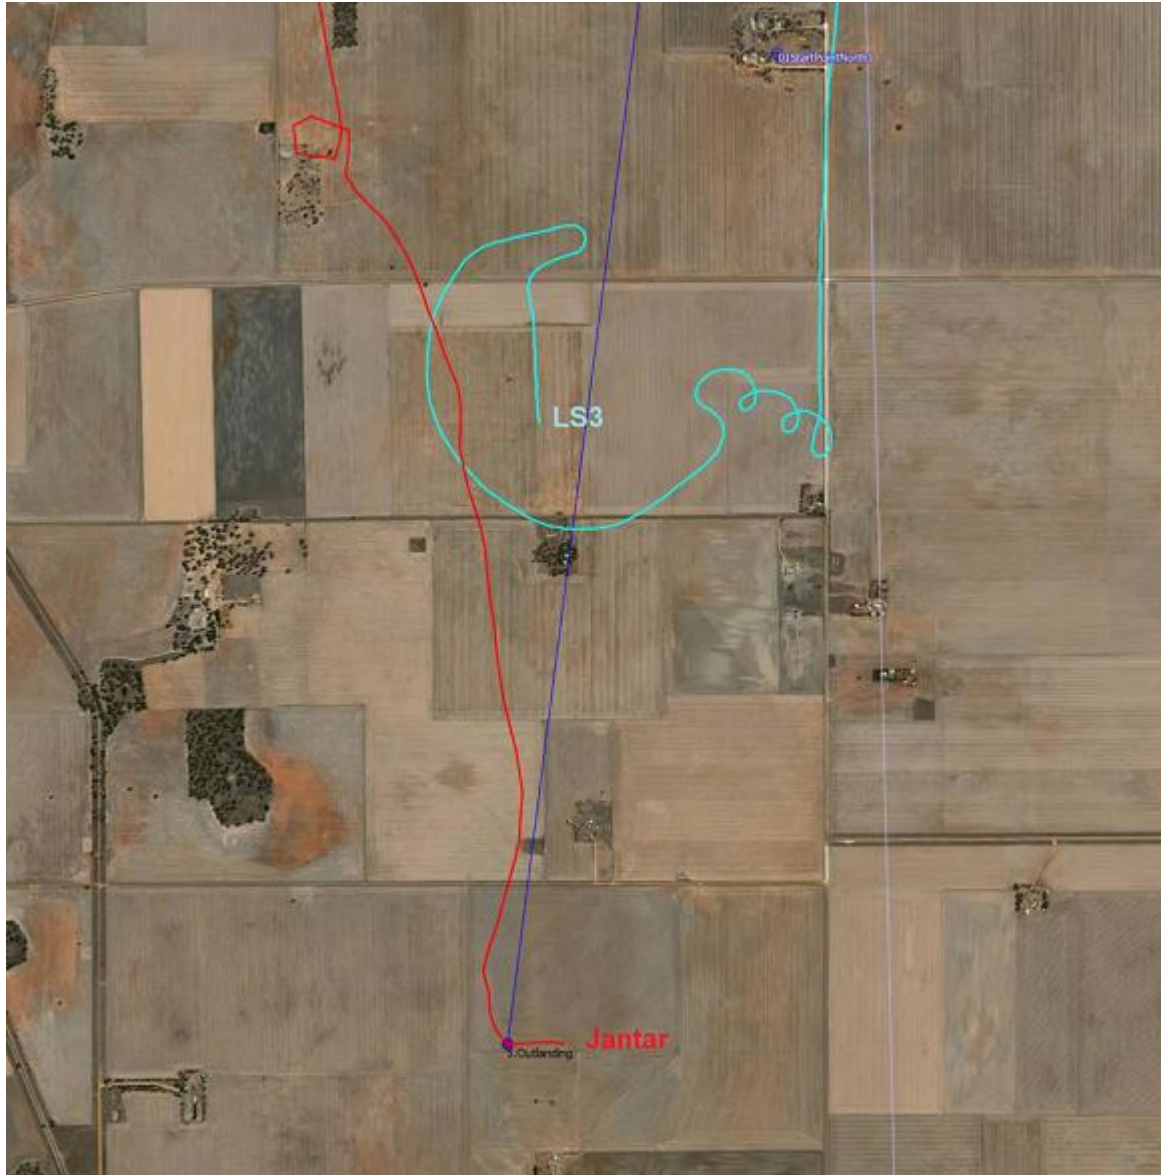
Figure 2. Flight tracks from logger traces.

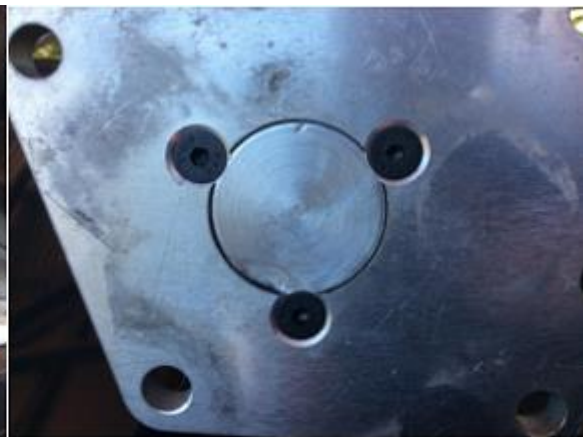
Picture 2 Dummy shaft mounting with new high tensile screws fitted.

Remedial Action

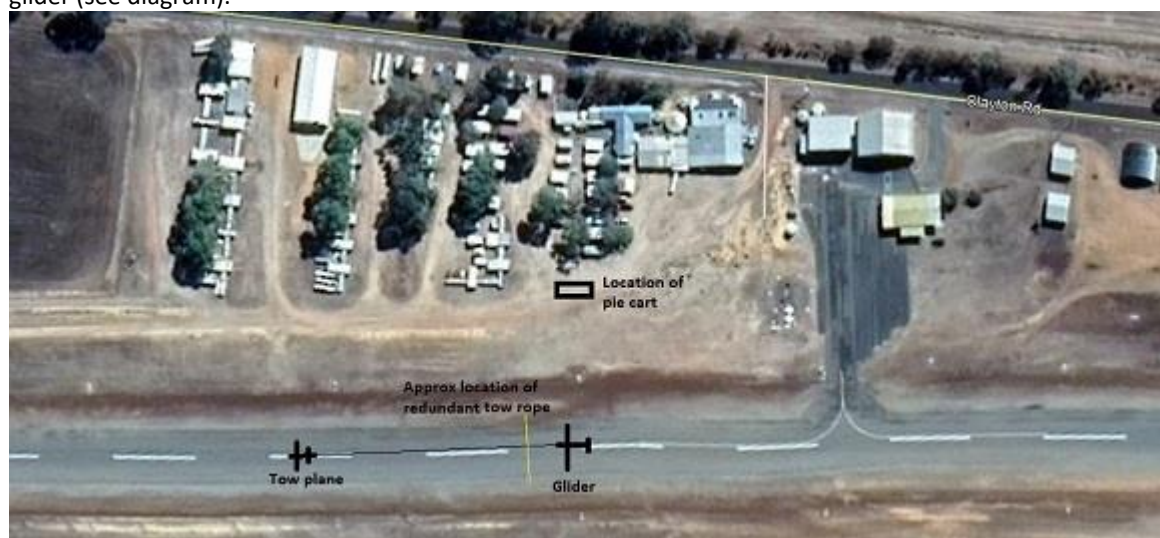
The incident occurred at the beginning of a training flight with an experienced Level 2 instructor and a pre-solo student. The launch crew comprised a wing runner and another person who attached the tow cable, both of whom were current glider pilots. There were several other glider pilots, including at least one other instructor, observing the operations from the pie-cart, approximately 30 metres to the north of the launch point. The pie cart contained a functional VHF radio transceiver, tuned to the CTAF frequency. Operations were being conducted on RWY 28, which has a sealed surface approximately 25 metres wide, with a 13-metre-wide gravel verge on either side. A redundant tow rope was laying across the path of the launching glider (see diagram).

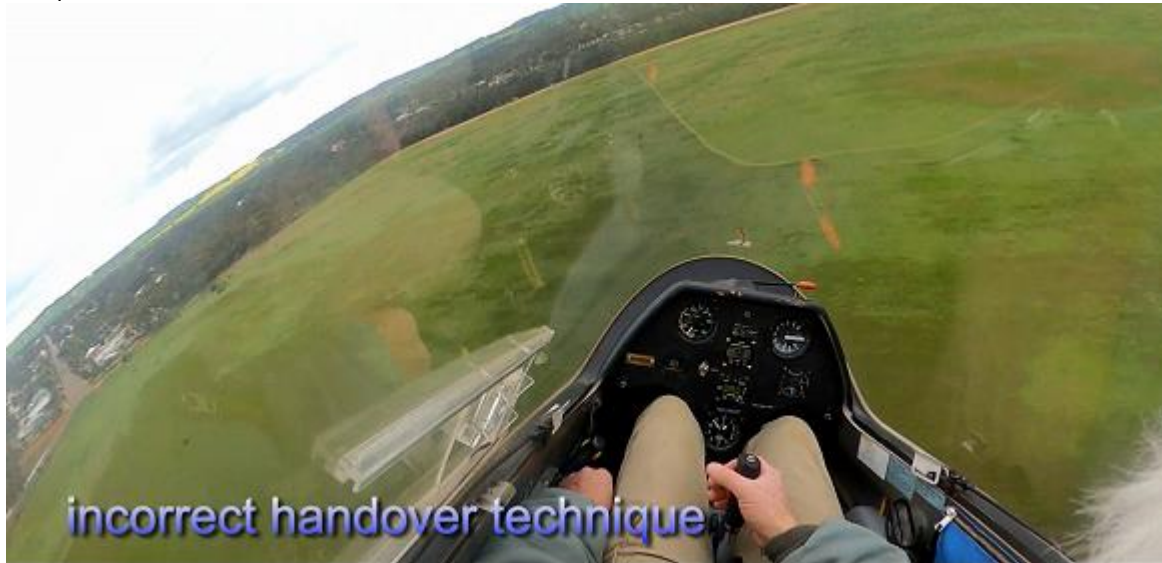
standard phraseology of "You can have it" and then raised his left hand. The command pilot heard the rear pilot say "Yep", which he interpreted as an acknowledgement from the rear pilot, and then held up two hands to the top of the front canopy to signify he was no longer on the controls. However, the rear pilot advised that the noise in the cockpit was so loud that he didn't hear what was said, and as he was focused on taking the video of the flight, he did not see the handling pilot's hands go up when control was relinquished and so did not take-over control.

The moment the command pilot took control.

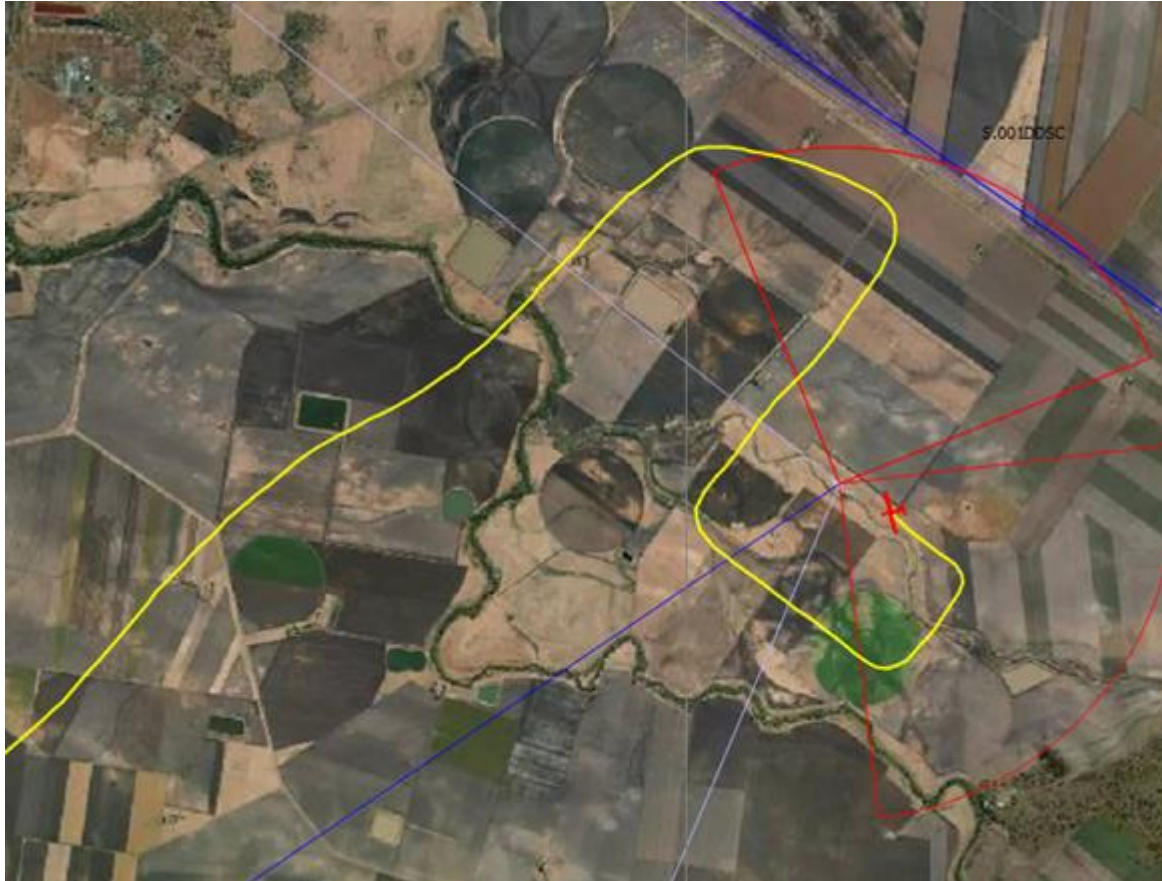
The pilot joined circuit slightly lower than normal and, despite losing further height due to sinking air, did not modify their aiming point. The pilot turned onto base leg so low that they were unable to turn tight enough to align with the runway and landed in a paddock alongside.

The command pilot had flown a 150km cross-country flight with another pilot as crew and commenced final glide at 6000ft about 55kms from the aerodrome. The command pilot flew the final glide at 100 knots and encountered severe sink in the last few kilometres. The pilot did not want to conduct an outlanding, having outlanded the previous day, so decided to join circuit much lower than normal from the opposite side of the runway instead of turning earlier onto a left-hand circuit. The pilot flew across the upwind extended centreline of the operational runway towards the opposite side of the circuit at about 1500ft AGL and at a distance of about 2NMS. The pilot then turned onto the crosswind leg for RWY30 about 500 metres upwind and at about 1400ft AGL. The glider flew through areas of strong sink and the pilot eventually turned onto the downwind leg of the standard circuit at about 700ft AGL. The glider continued to fly through sinking air losing height, but the pilot maintained the standard circuit pattern. The base leg turn was made abeam the glider control van at a height of about 300ft AGL and the glider attained a wings level attitude at about 100ft AGL. The glider flew over the glider control van at a height of about 10 metres and the pilot then undertook a shallow a 90-degree turn to line up with the runway. Due to the low height, the pilot could not bank very steeply, and the glider overshot the runway and landed in a paddock on the edge of the runway. The pilot's CFI witnessed the landing and spoke with the pilot, who advised they wanted to land close to their car and tow gear, and to have some privacy for a 'convenience' stop. The CFI counselled the pilot and reiterated the advice in Operations Safety Bulletin (OSB) 01/14 'Circuit and Landing Advice'. To quote from this document, *"The final turn must be conducted at a safe height, preferably not lower than 300ft AGL, and at the calculated approach speed, having regard to the local conditions. Good energy management is critical to safety, and to setting up a good stable approach from which a safe landing can be conducted. There is strong*

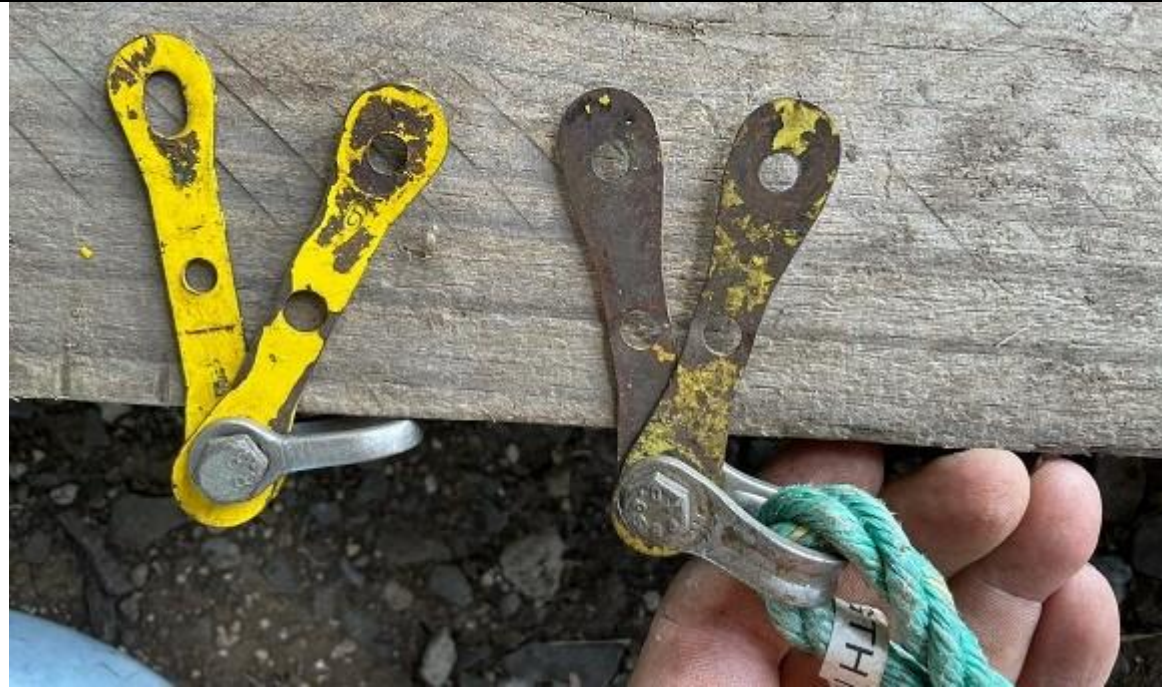
Date	4-Sep-2021	Region	GQ	SOAR Report Nbr		S-1901		
Level 1	Operational		Level 2	Miscellaneous		Level 3	Other Miscellaneous	
A/C Model 1		Piper PA-25-235			A/C Model 2		N/A	
Injury	Nil	Damage	Nil	Phase	In-Flight		PIC Age	62
What Happened The tow pilot identified that the TOST weak link fitted to the tow rope had been incorrectly assembled and was double the rated strength.								
Analysis The tow pilot was inspecting the weak link and tow rope for serviceability as part of the Daily Inspection before the day's operation when he noticed there were two equal link inserts fitted to the weak link. Both inserts had round holes rather than one having an elongated hole, which effectively doubled the breaking load (see photograph). There were no records of when the weak link had been changed, but it is believed many aerotows had been performed in this configuration. The tow pilot replaced the weak link and ensured the correct inserts were fitted.

The TOST weak link system is an engineered and approved system which prevents aircraft overloading in winch, autotow and aerotow operations. By using this system, the operator is assured of maintaining the manufacturer's airworthiness requirements for protection of both tow plane and sailplane. The GFA recommends clubs and operators use the TOST reserve insert and sleeved weak link system. This uses two weak links in parallel protected by a steel sleeve. Both weak links have attachment holes at each end and are 8 mm in length. The reserve has oval attachment holes and carries no load in normal operations. If the load exceeds the rating, the weak link will fail and the reserve link will take up the load. If the load is more than a momentary jolt both weak links will fail. For further information, refer to Operations Advice Notice (OAN) 01/13 'Weak Links – Selection, Application, Safety and Testing of Glider Weak Links'.

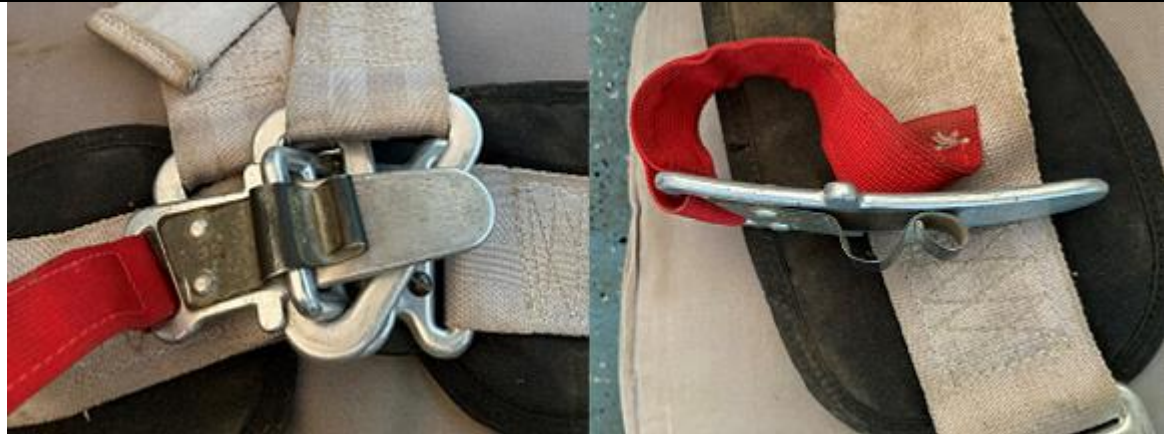
On the first occurrence, as the control column was held back and moved across to the right, it struck and pushed the locking clasp out of safety and the harness became undone. The second and third occurrences occurred when the pilot knocked the locking clasp open with his hand. Three factors were identified as contributing to the first occurrence:

- The glider trims nose heavy, making it necessary to hold the control column near full back stop when flying slowly.
- This style of harness can be released by applying pressure laterally to the end of the aluminium tongue.
- The front seat pilot was rotund, which placed the buckle in a position where the backward movement of the control column during thermalling allowed it to contact the buckle. When the control column was moved from left to right it pushed the harness tongue out of safety.

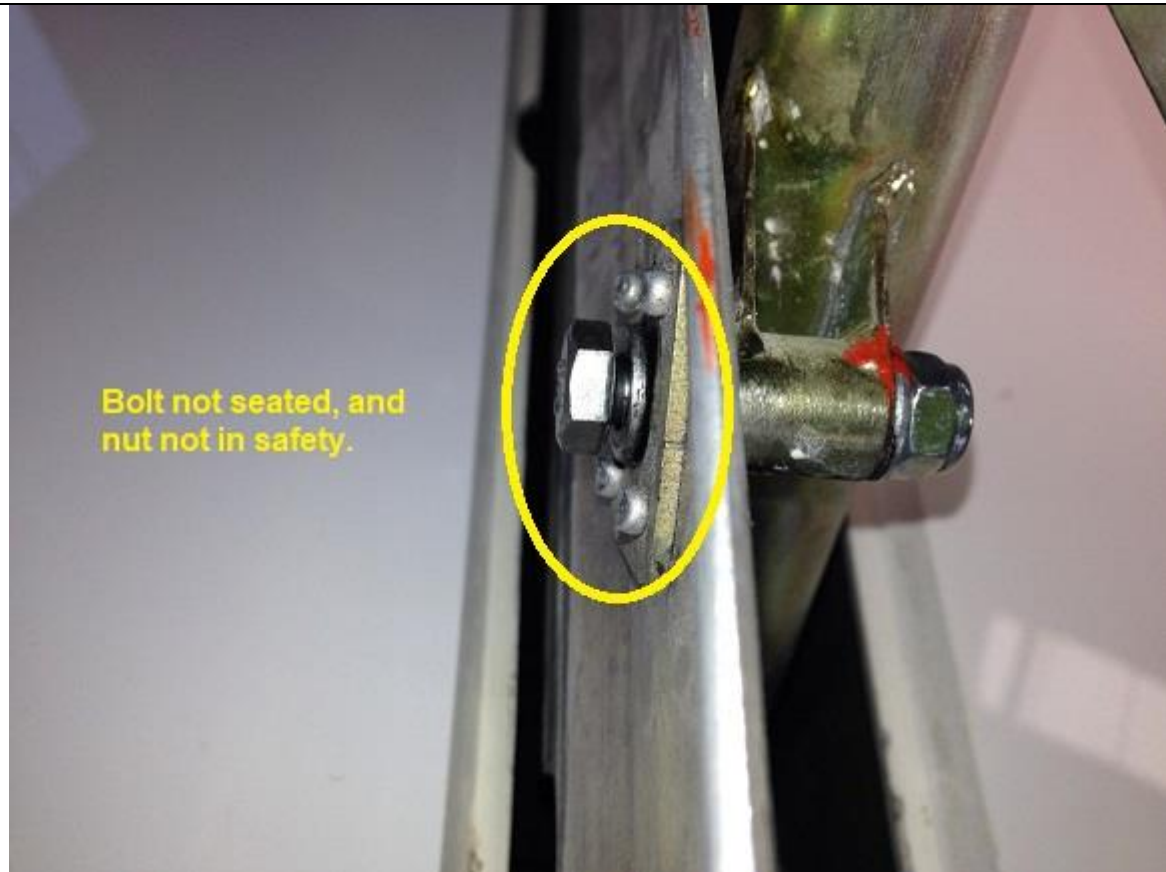
During the Daily inspection, the inspector noticed that the locknut on the port inboard airbrake pivot arm was not in safety. Paragraph 5.5.1.a of the document Basic Sailplane Engineering requires that at least one full thread must be showing through the elastic insert for the bolt to be in safety. Investigation revealed the bolt was not seated against the rear of the airbrake and had not been pulled tight by tightening the locking nut (refer photo). The lock nut was finger tight. The lock nut correctly tightened, assessed as functional and the aircraft was returned to service. It is believed the nut was not tightened and made safe during the previous annual inspection. The aircraft had been subject of 29 Daily inspections since the last annual inspection.

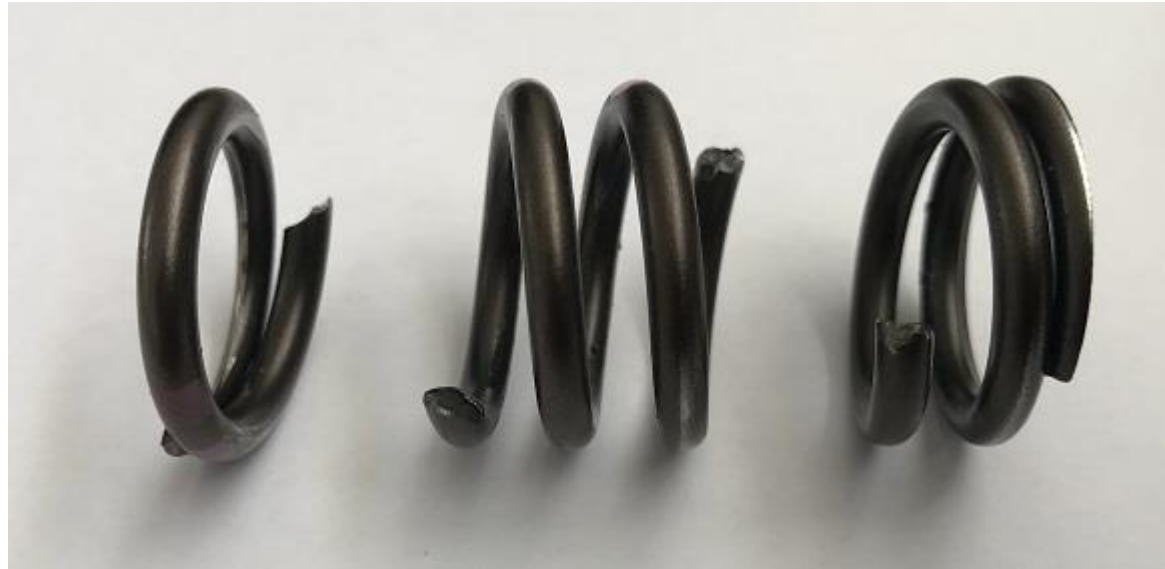
Fortunately, the pilot was able to turn speed into height and, with some thrust still being delivered by the engine, managed to fly back to the airport and land safely. Post-flight inspection revealed the exhaust valve spring of the No. 4 cylinder had broken in two places. Examination of the maintenance records identified that the leak down test performed the previous week measured cylinder No 4 at 78/80 relative to cylinders 1,2 & 3, which measured 79/80. It is therefore believed likely that one of the breaks in the valve spring was present at that time, but still allowed the valve to close effectively and thus masked the problem. Two replacement used springs were obtained and a field repair was successfully conducted a few days later and the aircraft performed normally during the remainder of the trip. Upon arrival back home, the spring was examined by a University of Queensland Materials Performance Laboratory expert using a stereo microscope. This examination revealed that there were inclusions, and stress markers near those inclusions, which led to the failures. The fractures almost certainly occurred sequentially and not simultaneously. Rotax has been advised via Australian agent, Bert Flood Industries, with the submittal of a Rotax Customer Service Information Report. The failed spring was returned to Rotax as requested.

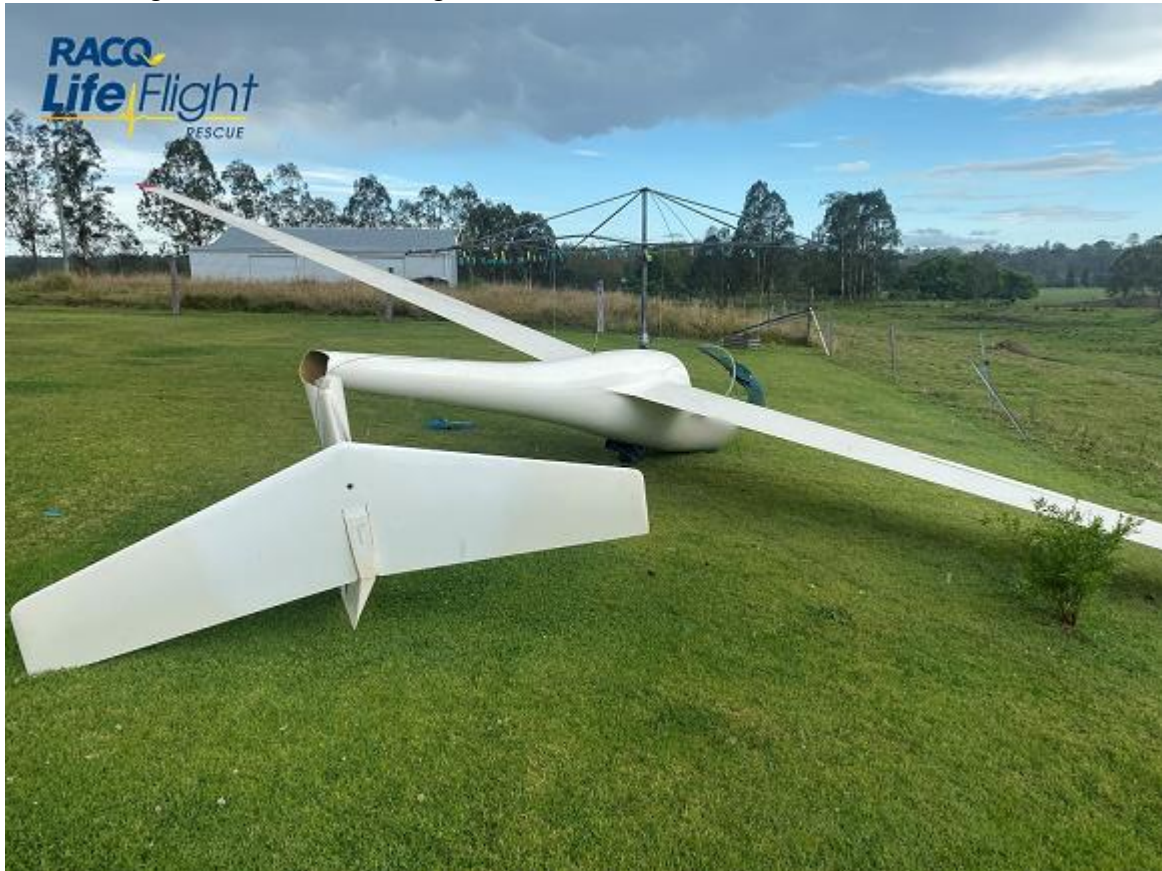
While outlanding, the pilot crowded their circuit and overshot the intended landing area. The glider touched down heavily in the following paddock that was upward sloping, and passed through a barbed wire fence before striking the hills hoist and coming to rest near the farmhouse.

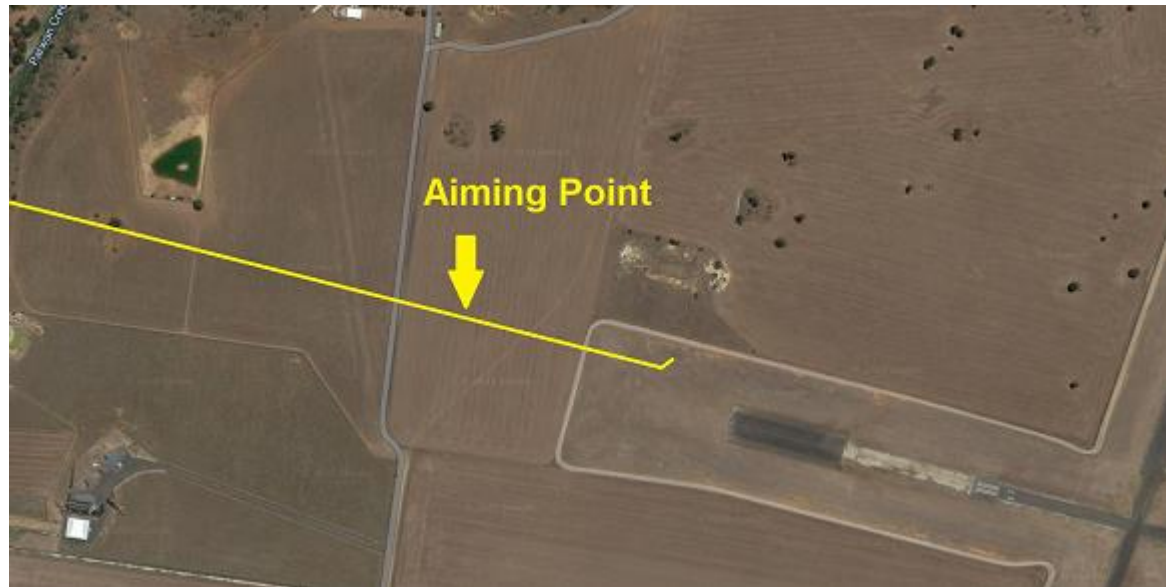
flew at very low level over the paddock. As the glider approached aerodrome boundary fence while flying only a metre above the ground, the pilot pulled-up but the main wheel struck the top strand of the wire fence, which tore off the undercarriage doors. The glider came to rest just inside the runway undershoot area.

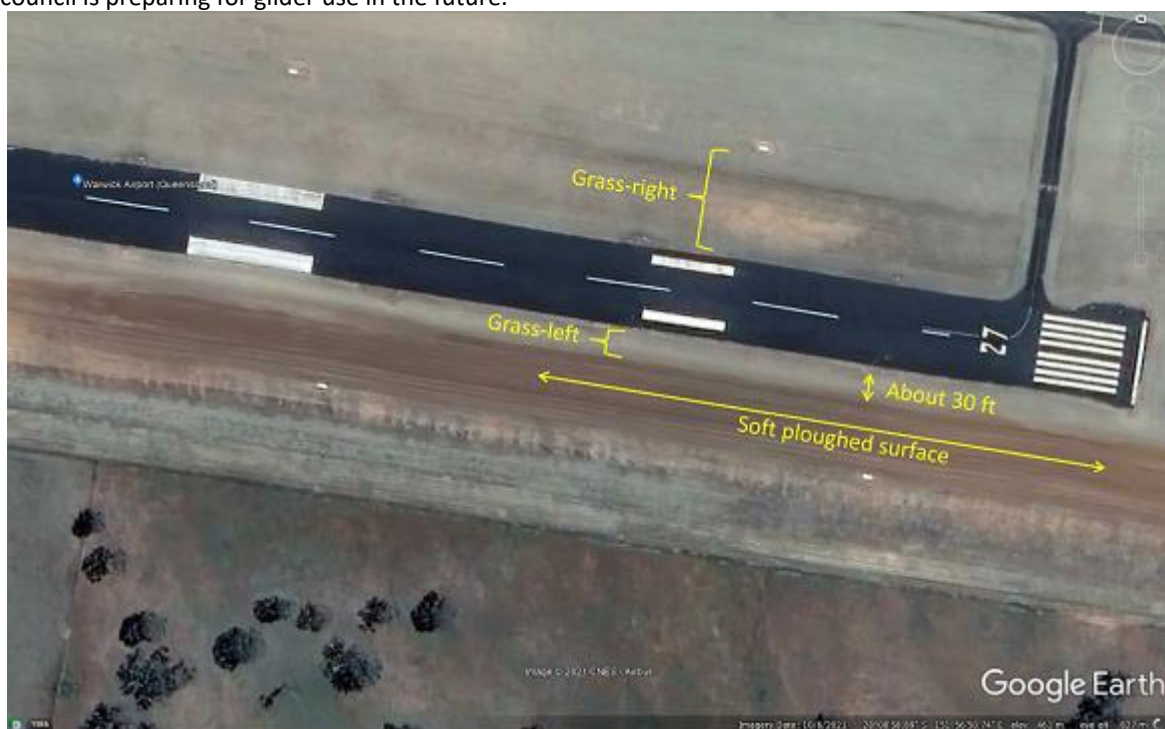
Figure 2 Runway 27 layout

At about 1013 AEST, the student turned the glider from base leg, onto final runway 27 (Figure 2), lining up with grass-left. Runway 27 grass-left had about a 30 ft (10m) wide firm strip adjacent to the bitumen, that the tow aircraft had been using. To the left of the firm strip was a wide, soft, ploughed area that the local council is preparing for glider use in the future.

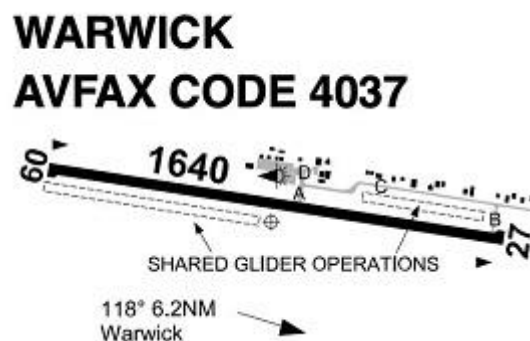
Warwick (YWCK) airfield is a non-security-controlled airfield that hosts general aviation and glider traffic where an AAFC Glider Training School and the Warwick Gliding Club are located. In addition to runway 09/27, the ERSA identifies two shared glider operations areas known as 09 grass left and 27 grass right as shown below.

At the time of the accident the area to the left of RWY 27 was in the process of being developed into an area for glider operations by the aerodrome owner. The condition of the area was ploughed and unlevelled. Approximately an area of 30ft (10m) wide grass to the left of RWY 27 was present before meeting the soft ploughed surface. During the Daily Briefing, it was identified that RWY 27 Grass Left was not suitable for landing gliders, although tug aircraft were using the narrow strip of grass for landing. The sortie was the 16th launch of the day, and the first for the PIC and student. The objective for the sortie was to review decision making in the circuit and further development of speed control/attitude from downwind to final approach. The Duty Instructor at the time was aware that the glider was landing on the grass area to the left of RWY 27 but did not take any action to alert the aircraft that this area was not to be used for landing. During the landing neither the instructor nor the student could recall if the instructor announced that they were taking control of the aircraft. On 17 December 2021 all instructors were briefed on the incident and undertook a check flight, which included taking control of approach and landing, and recovering from poor landings.

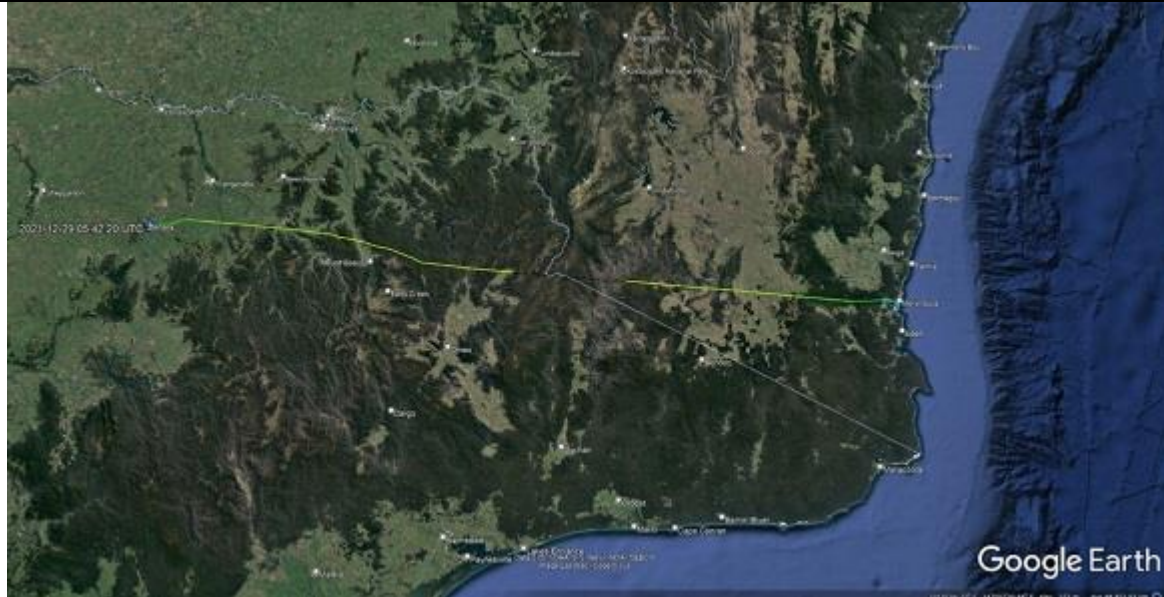
Figure 1: Flight track from transponder data

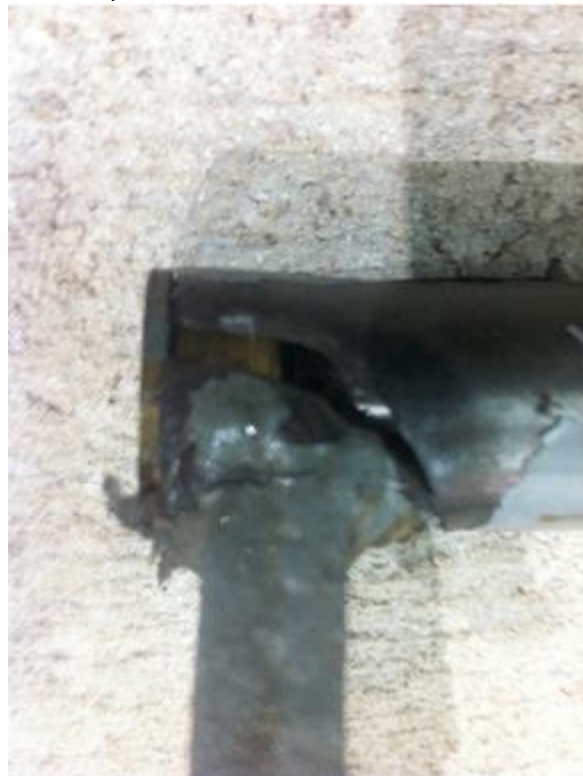
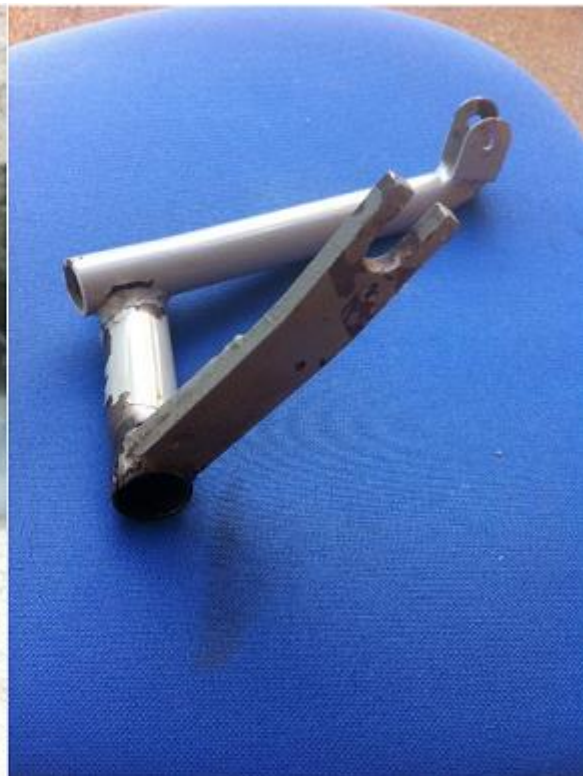
Subsequent inspection at an approved maintenance organisation identified that a critical part of the undercarriage mechanism broke on touchdown, causing the undercarriage to retract. It was determined that either a heavy landing or a series of heavy landings over time had weakened a part of the mechanism, which eventually failed.
