# The Gliding Federation of Australia Inc

## Occurrence Summaries

01/01/2023 to 31/12/2023

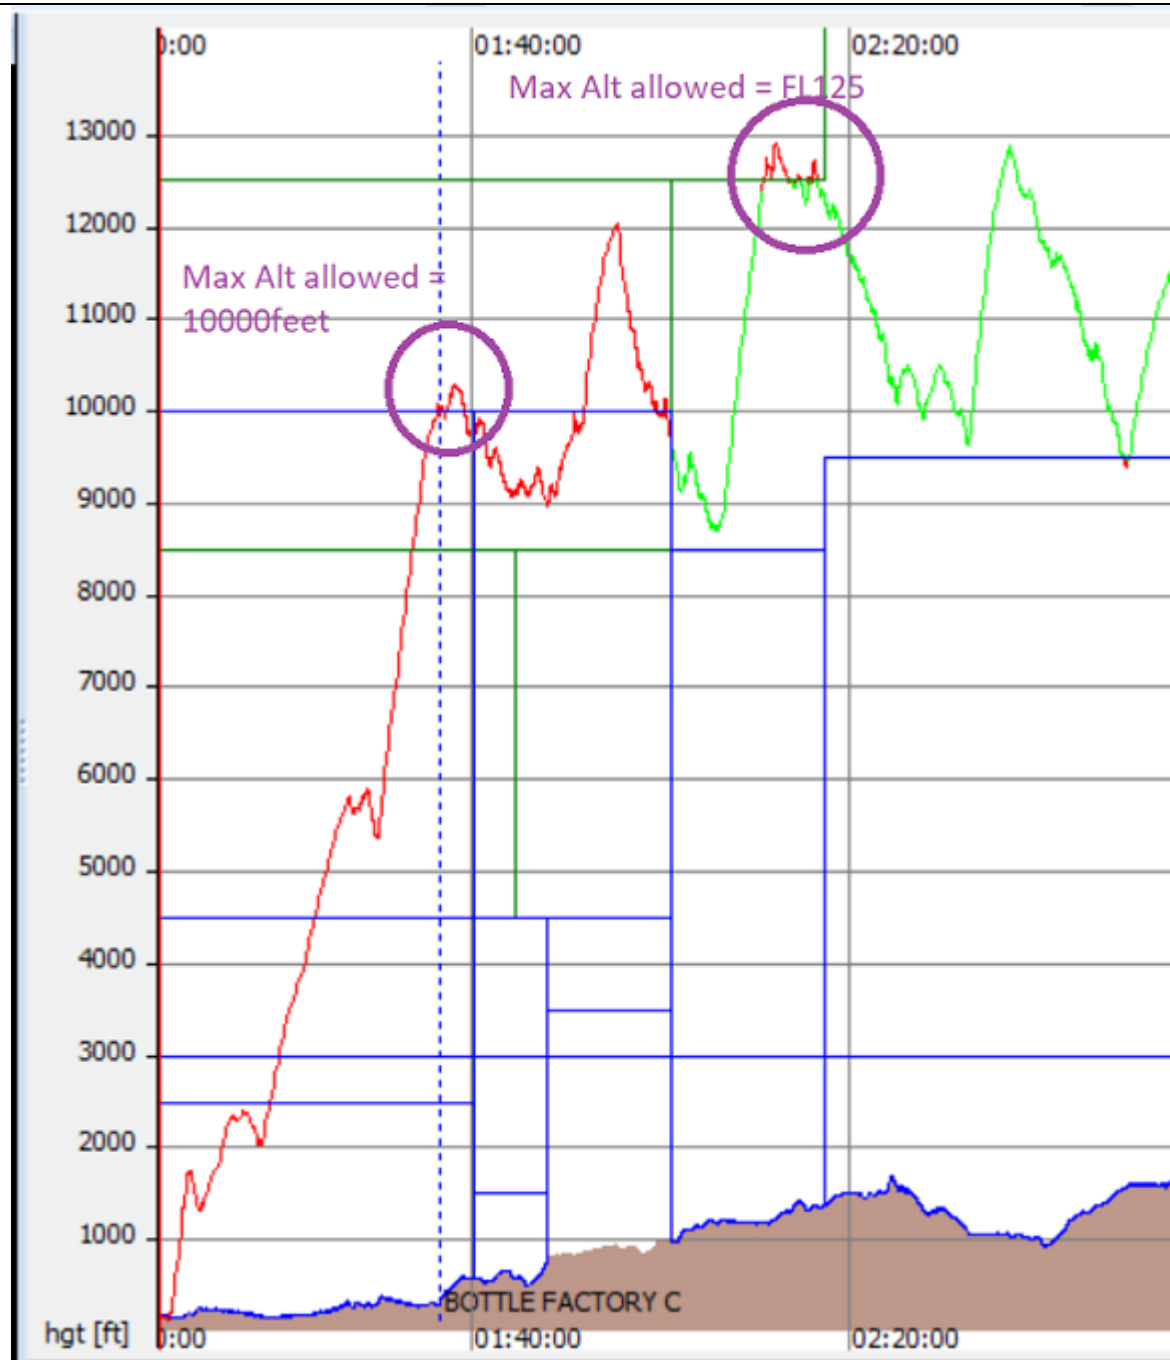
A post-flight review of the logger trace indicates the pilot have exceeded airspace later in the flight. As the pilot flew north abeam Auburn, SA the trace file indicates the glider flew above FL125 and into Class 'C' airspace.

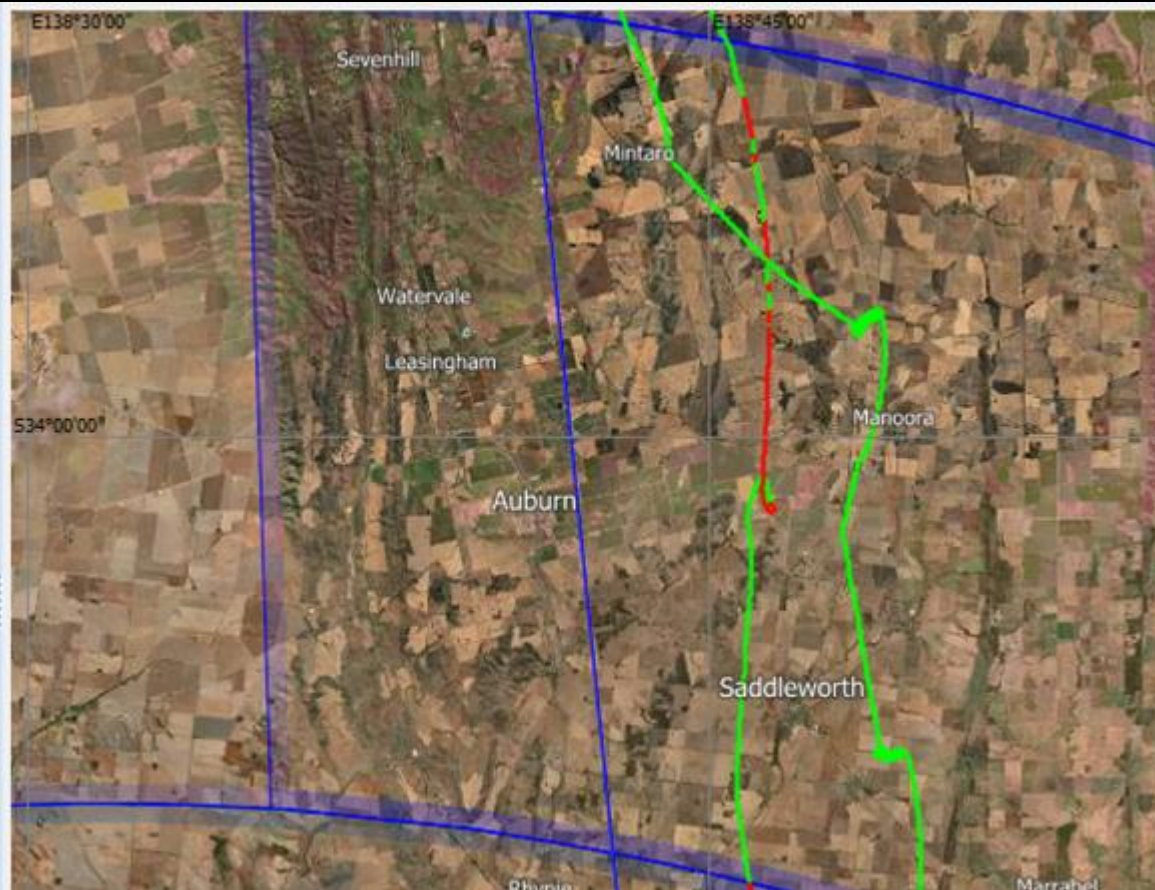
The trace file shows that the glider reached 12,917 feet in this area. When the CFI spoke to the pilot about this breach, the pilot disputed exceeding FL125 on his altimeter; suggesting that the trace file from his tablet computer only recorded GPS altitude and was not linked to his calibrated altimeter. Notwithstanding, the pilot was not confident that he had been adequately monitoring the altimeter. **Analysis**

The aerodrome from which the pilot was operating is situated beneath Class C airspace (LL4500), and within and between several areas of restricted military airspace and Danger Areas. On the day of the flight the Danger area D206 was active and allowed gliders to fly in restricted airspace by arrangement with the RAAF to a height of 10000 feet. The pilot is an early cross-country pilot with only a couple of seasons of flying cross country. He also has limited experience flying with oxygen, and thus only fitted his oxygen cannular as he approached 10,000 feet. As he concentrated on fixing the cannular and getting his oxygen system working, he climbed into controlled airspace. After the flight the pilot recognised that his primary error was not using the oxygen system much earlier in the flight and thus his oxygen saturation levels may have been a contributing factor in his airspace infringement. The pilot was using a moving map display on a tablet computer running XCsoar, but the program did not have an alerting function on.

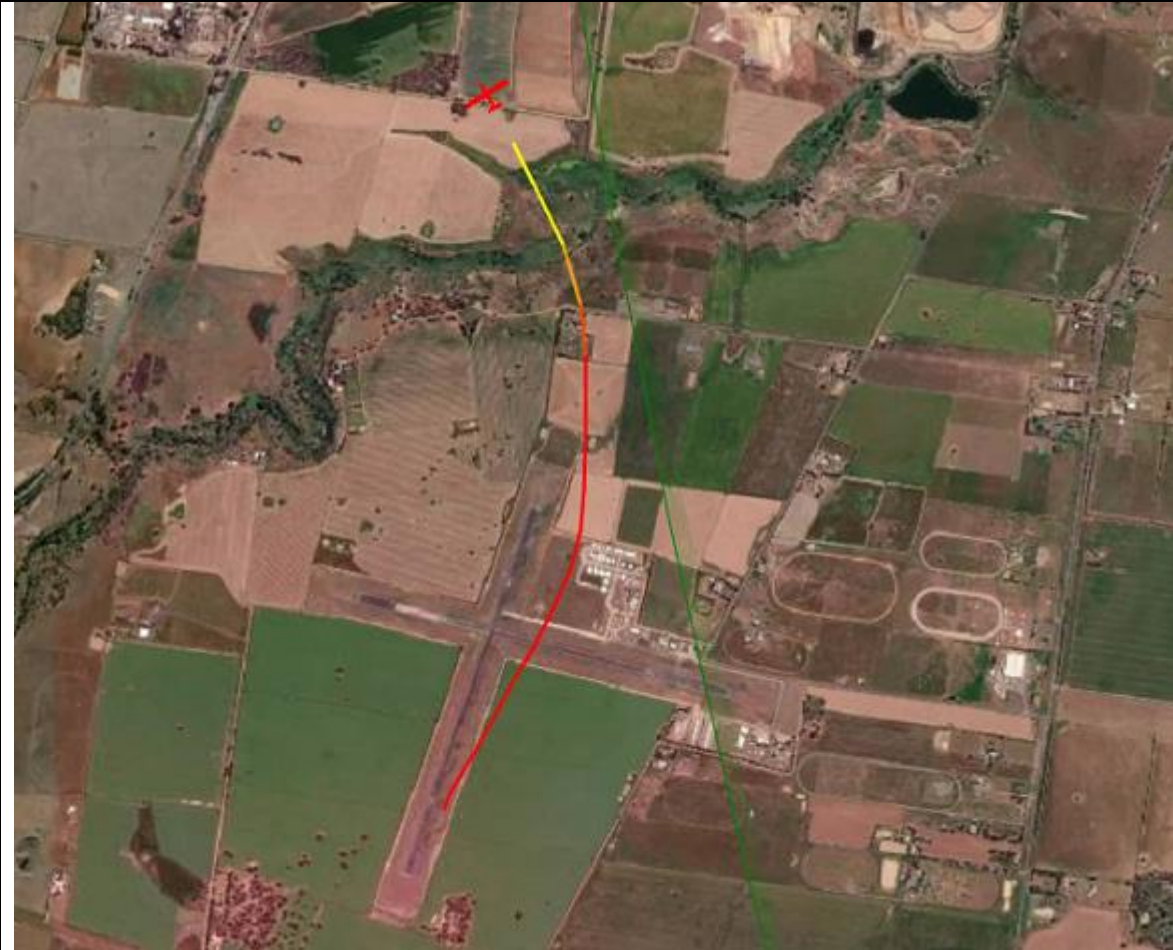
The towing combination comprised a DG-1000 glider being flown by a pre-solo student pilot under instruction and a Pawnee tow plane flown by a low hour's tow pilot. A tow pilot who observed the take-off advised that the wind was 15kts, and probably gusting to 20 kts. The drift started just when the tug got light on the undercarriage, and about 5-10 seconds later the combination was climbing over the boundary fence. At that time, other gliders were landing on RWY 27, which was more into wind. As the tug started drifting to the right, the gliding instructor took control but elected to stay on tow as the combination had gained sufficient height and speed to clear the fence, and the instructor was concerned that had he released the rope may have struck the fence and potentially caused difficulties for the tow pilot. In hindsight, the instructor recognised that the flight should not have proceeded in the prevailing conditions, and that once the tug started to drift, he should have released and allowed the tug to safely climb away while landing the glider straight ahead on the runway. The Club CFI noted that the cause of this incident was most likely the result of a strong gust combined with incorrect inputs by the tow pilot, and it highlights why gliding duty crews must manage flight risks by moving operations to the most into wind runway in a timely manner.

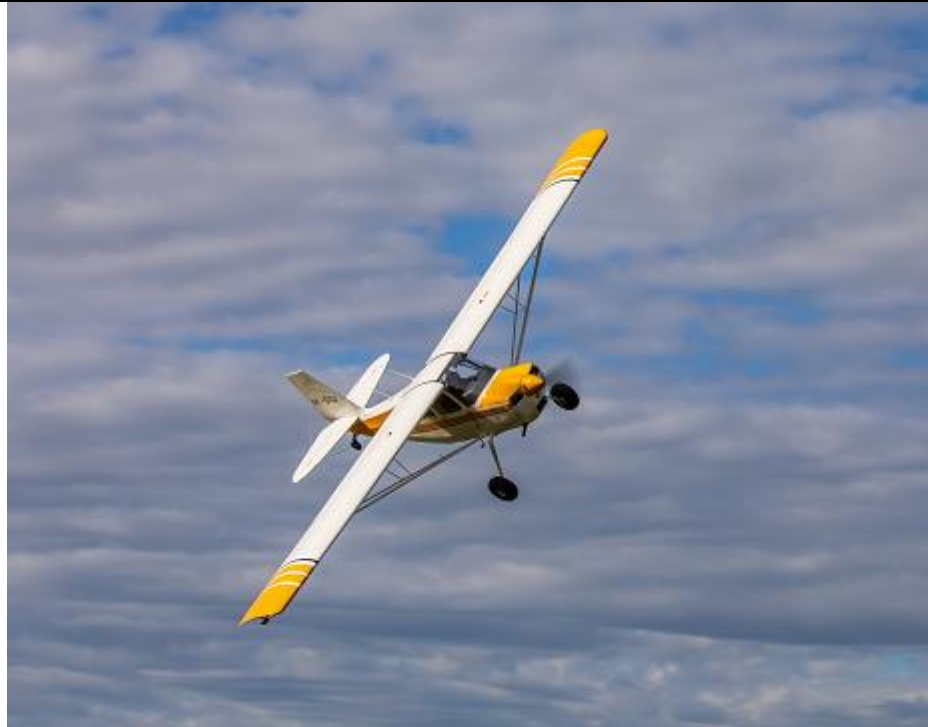
Gliding Operations were being conducted from RWY 12 Bitumen. Several witnesses observed the Scout taxi to RWY 04 and heard the pilot make a standard departure call. The pilot conducted a normal take-off but was observed shortly thereafter descending from the Northeast at what appeared to be a few hundred feet. The Scout continued to descend and then crossed the runway cross-strips diagonally above the Windssock at approximately 50 feet AGL. As the aircraft crossed, it climbed in a steep bank to the right heading Northeast and then continued to track on climb. Two witnesses reported the Scout's wingtip came within 2 metres of the ground during the turn. The gliding club CFI subsequently spoke with the pilot, who acknowledged that it was the wrong thing to do and advised that it wouldn't happen again.
