GFA AD 599
(ISSUE 2)

GFA AIRWORTHINESS DIRECTIVE

SUBJECT: In flight failure of wing structure. Issue 1 of this AD temporarily grounded the above aircraft while investigation of the cause was carried out.

SUBJECT: Wing,
bonding of spar cap to spar web

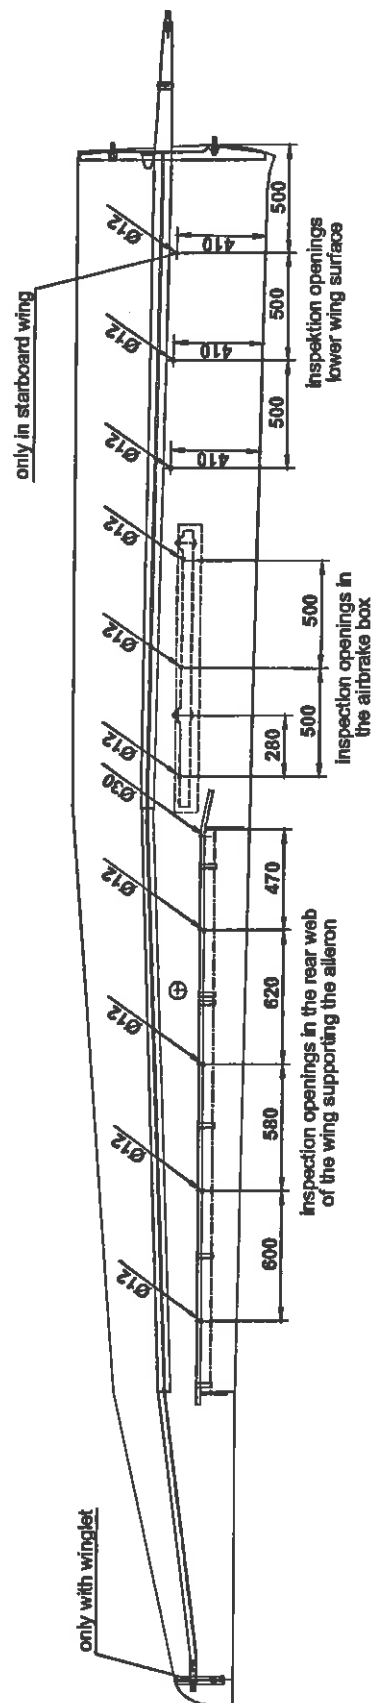
Starboard Discus-Wing
(bottom view)

It is recommended to start the inspection through the opening in the root rib inboard.

If an area can not be clearly identified (lighting conditions insufficient) additional inspection openings may be required:

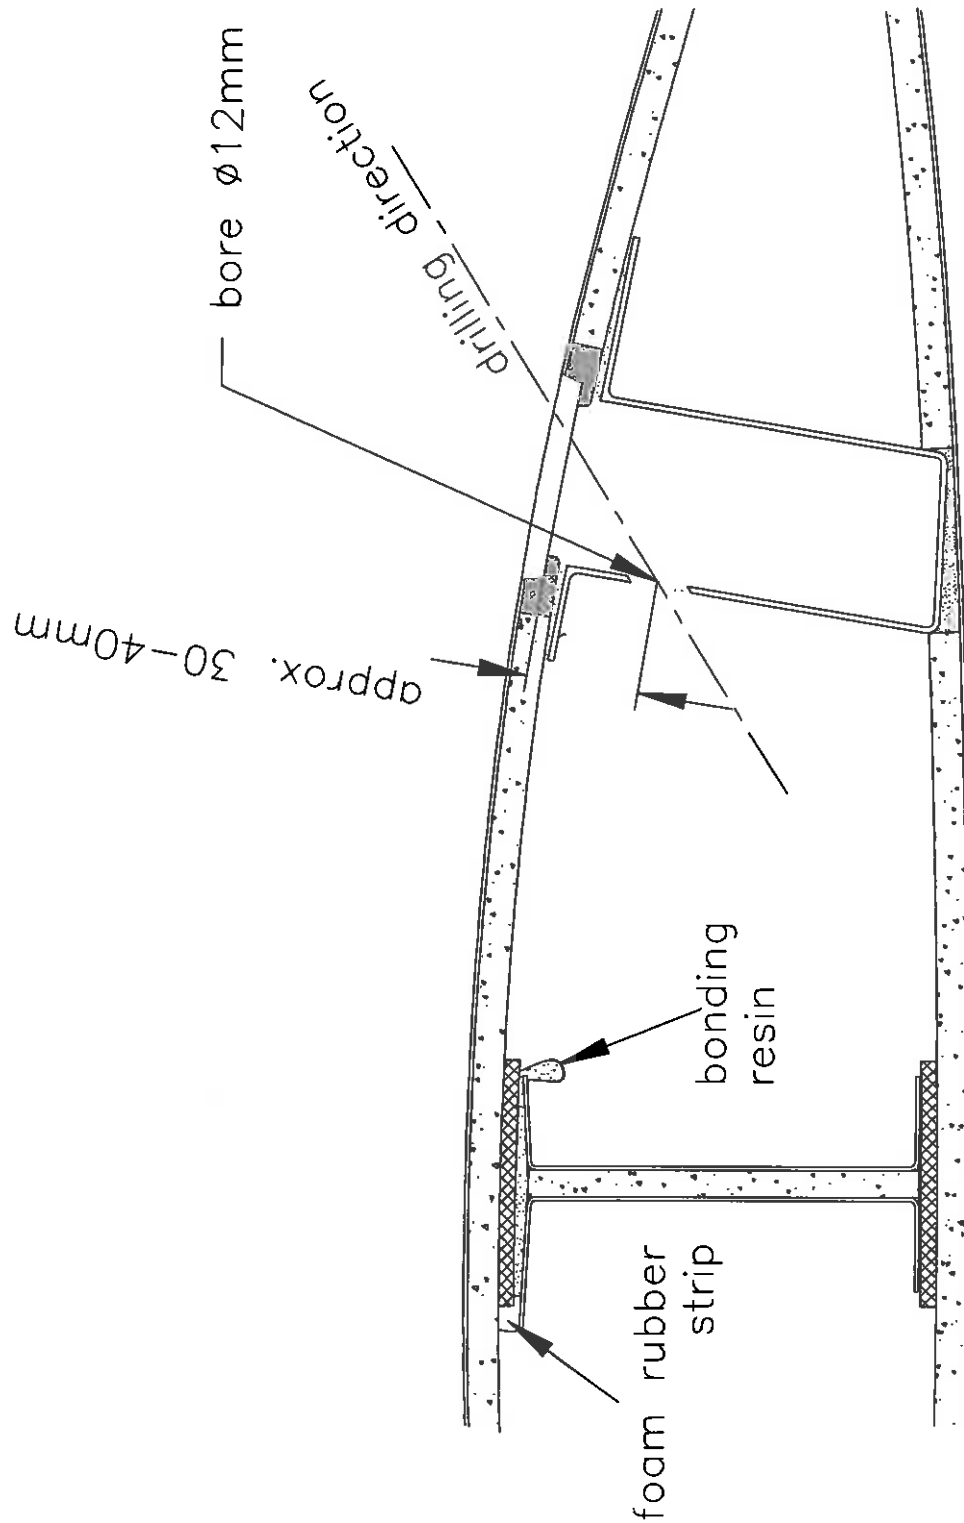
Wing cross section in the airbrake area

5. Defects in the bonding of the spar cap to spar web connection:

If defects were noticed the gap depth and length should be identified with a pointer with markings for the depth (wire diameter approx. 0,7 mm and/or a thin metal sheet thickness approx. 0,3 mm).

When identifying the area of the gap, always investigate the extension of the void in span wise direction. Some photos on page 9 and 10 show examples of defects in the bonding.

To repair the spar cap/spar web connection the opening in the lower surface has to be increased accordingly so that the repair can be done.

II. Deficiency in the bonding of more than 15 mm from the edge of the web or exceeding 40 mm in length or within the flange of the spar web

1. In the area of the deficiency sand the spar web away and scarf the edge of the web flange.
2. After roughening of the spar cap and the surrounding spar web apply the following layers 92125 under 45 degrees over the area to be repaired:
