GFA AIRWORTHINESS DIRECTIVE

TYPE AFFECTED: PW-5 Serial no.s 17.12.022 to 17.12.024

SUBJECT: Inspection of push rod ends installed in aileron and spoiler drives.

No. BO-17-03-18

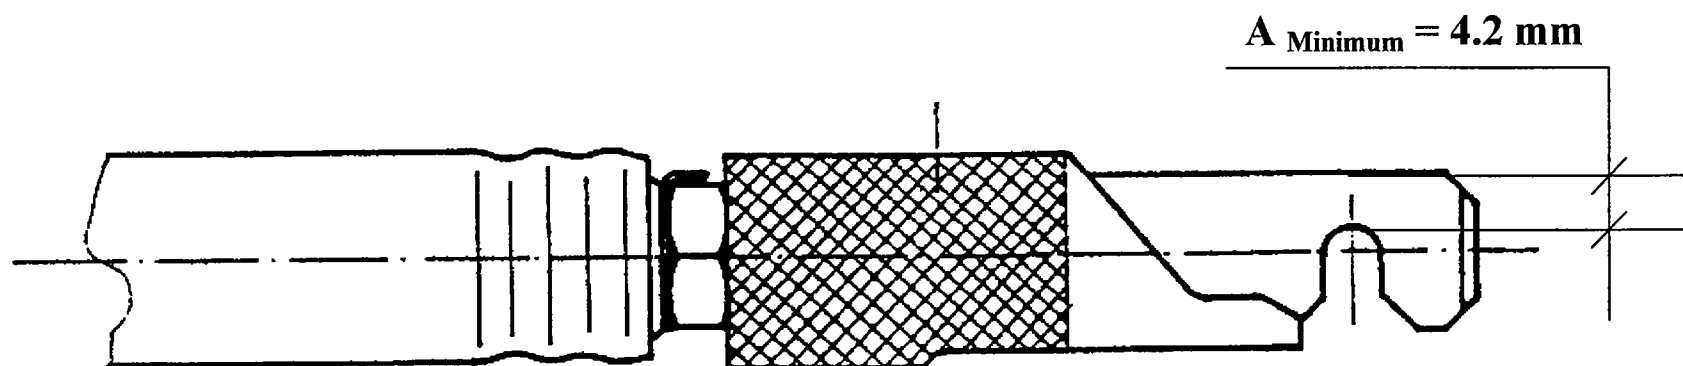
This bulletin is intended to advise the PW-5 sailplane operators that if the dimension defined on the sketch is found to be less than 4.2 mm, the flights should be discontinued and the sailplane must be parked until a particular push-rod end is replaced with a new one.

Inspect push-rod ends in the following sailplane control systems:

ACTION REQUIRED: As per instructions detailed in the Mandatory Bulletin, measure rod ends, and replace with factory supplied components if necessary.
